Project 1003 – Cook Car #053 Restoration

Project 1004 – Restore RPO X54 as RPO 54

Project 1005 – Plan Car Inspector’s House Repairs – Cumbres – 330.640

Project 1089 – Repairs to Sheep Car 5633 - Chama

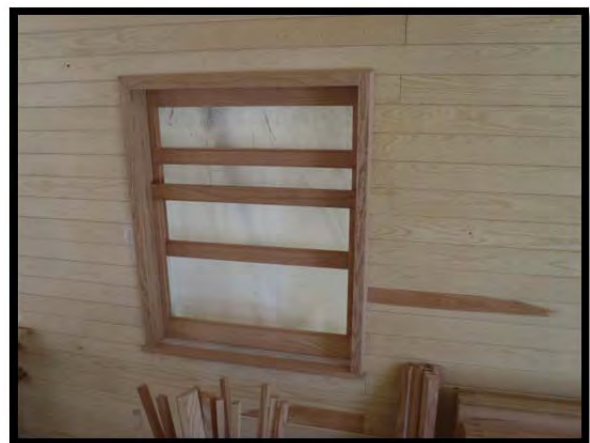
Window frames made by TL Don Bayer over the winder in place but will be removed later for painting.

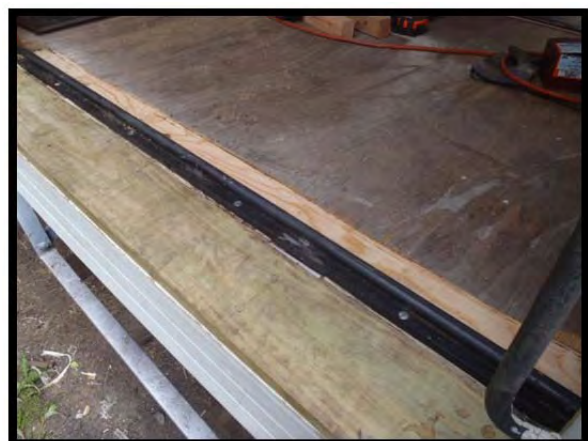
New door track installed with countersunk screws so door can travel freely back and forth.

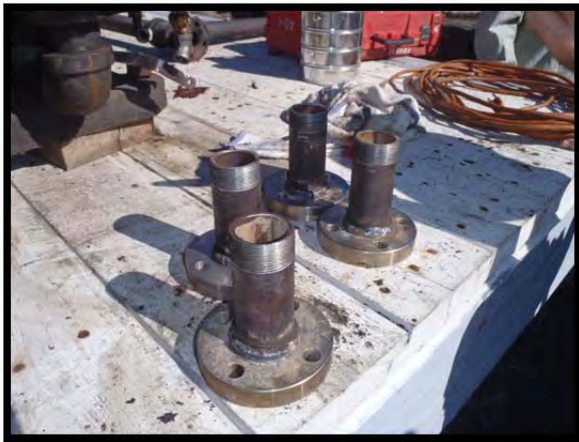
The winch was lowered the last 2" to the deck while work continued on steam piping. Cast iron flanges in the steam line were replaced with steel ones.

Replacement steel flanges before installation.

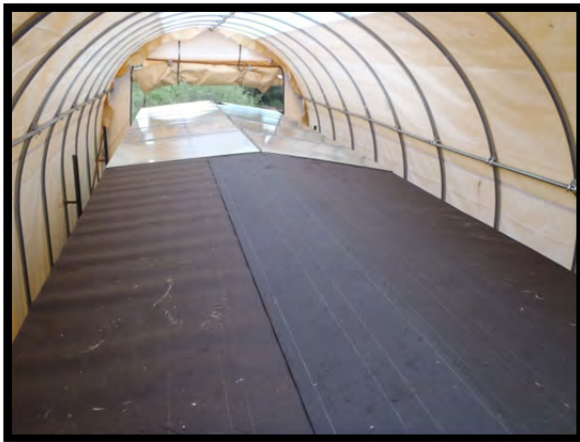
Felt paper was put on top of the new wood roof before the metal roof was put on. This should make the roofs of stock cars last a whole lot longer.

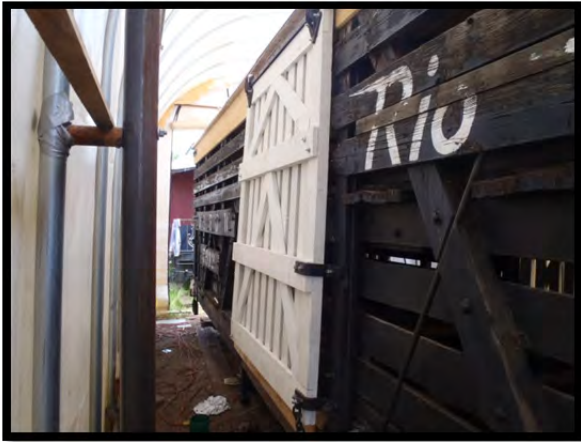
Built new doors for both sides of the car and replaced door tracks and door stops.

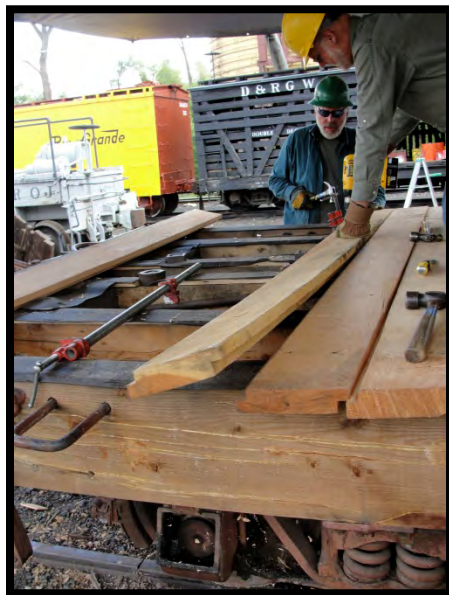
Badly warped lumber is hard to work with. 97

Comments: Much time on this project has been lost due to the poor quality of the wood provided. About two hours using pry bars, a “come along”, a sledge hammer, and several clamps were required to install one end sill, because of a badly warped side sill. All frame members were so warped that we had to install plywood shims before installing the decking, and the siding boards had to be clamped at every post to pull the boards into place. We were short three pieces of decking, due to unusable pieces, but were able to obtain replacements from the wood shop.

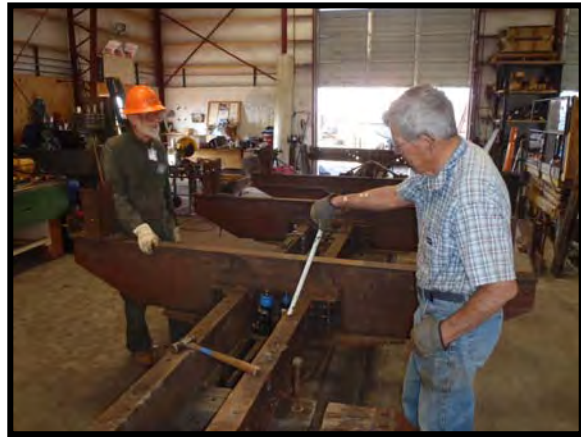
Warren Ringer watches as TL Bill Pratt is preparing to separate a cross-frame from the main frame utilizing hydraulic jacks.

Comments: It was intended to rebuild this car without replacing the frame stiffening beams (as done on all other Friends DBG projects), however this wood was so decayed that it was decided it must be replaced. Also, a frame repair indicated that one of the longitudinal frame channels was likely cracked, and removal of two stiffening beams was also necessary to inspect for this suspected damage. However, preliminary channel inspection failed to reveal any frame cracks.

Removal of the frame cross members and bolster saddle was required so that this wood could be replaced. It is planned to use Huck Bolts instead of “hot rivets” when reinstalling the three center cross frame members and the B end bolster saddle.
