## **Job 720 - Chama Freight Car Painting**

**Objective:** To paint the Chama Coal Tipple House, Sand House, Small Fire Shed and 3 High Value Cars (HVC).

## Job 0730 – Chama Freight Car Lettering

## Job 1003 – Cook Car 053 Restoration

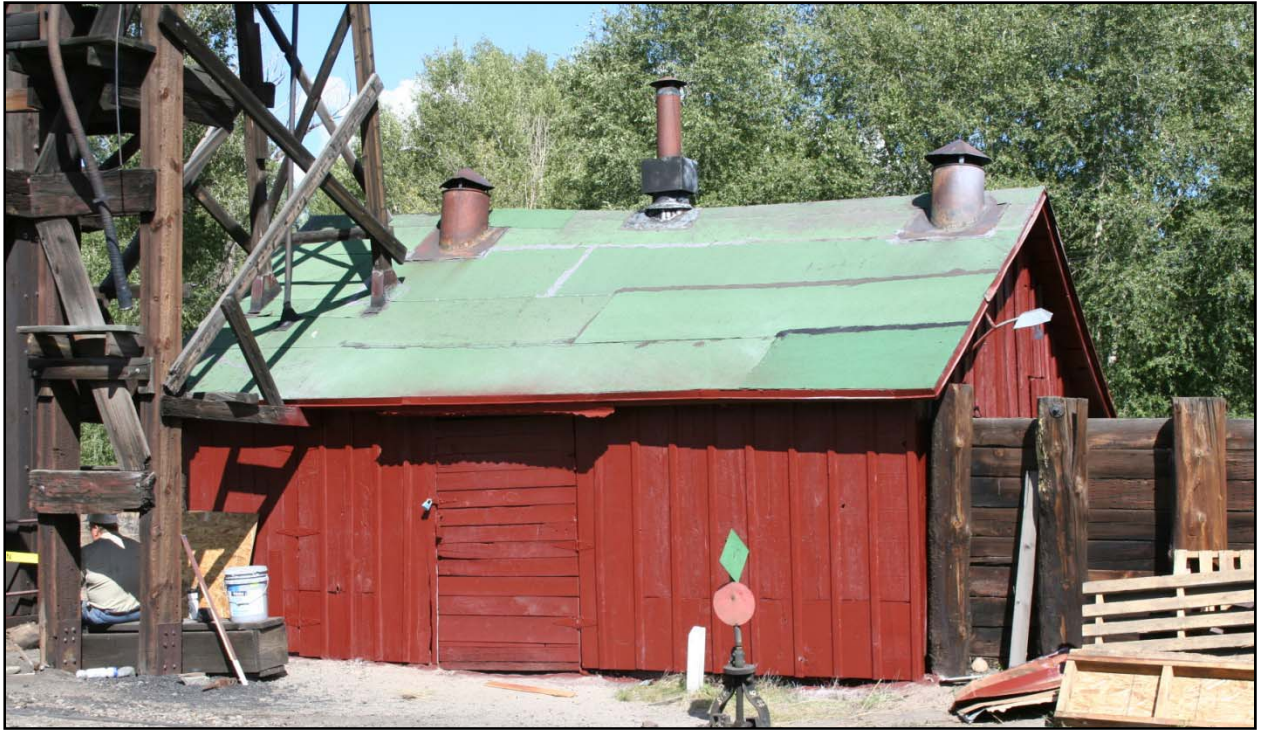
Finish coat of Latex Boxcar Red was applied on Wednesday, August 10, 2011. The right lower corner of the roofing was missing. The paint crew replaced the roofing before applying the final coat of paint at the request of the Site Leader.

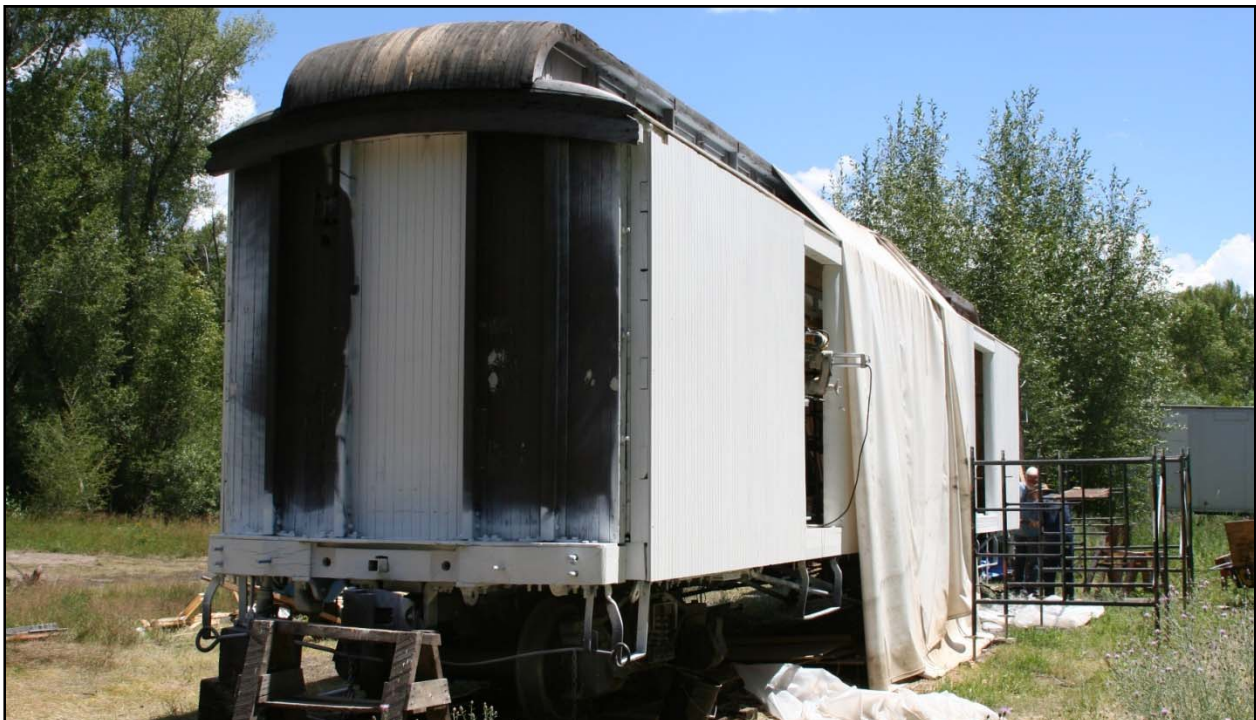
RPO #62 was primed with a thinned primer on August 9 and 10. Another primer coat will be applied in 2012.

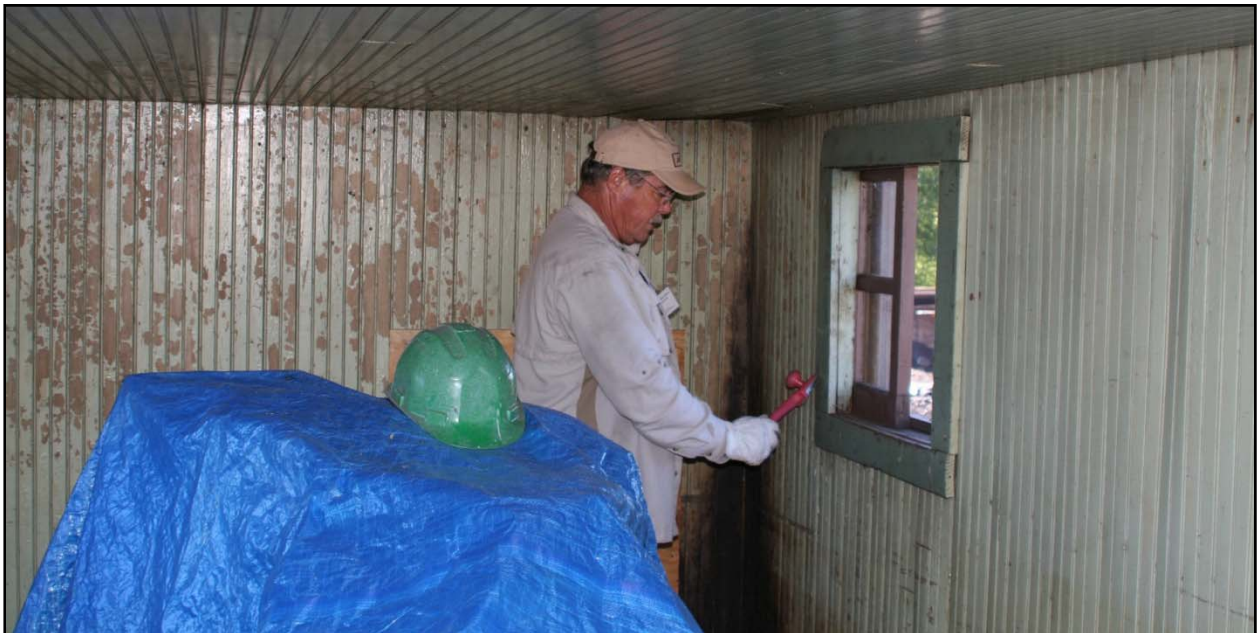
The interior of the Car Body Shed was scraped (including two locations where the walls were burned).

Two coats of white latex paint were applied to the interior of the Car Body Shed.

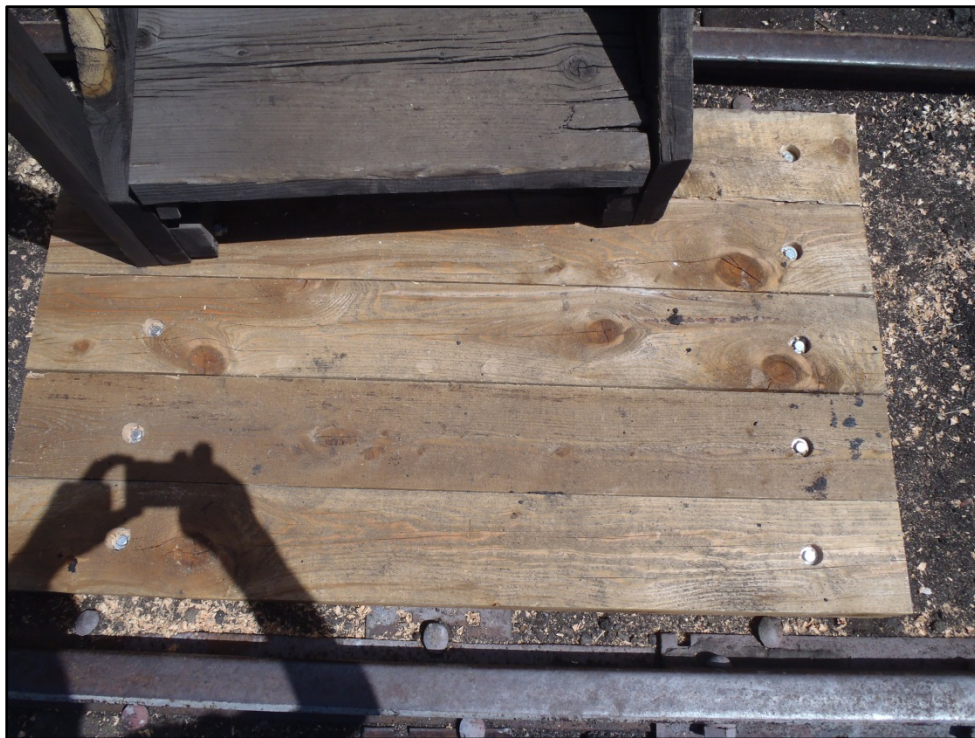
**Work Performed:** The current stairs had a fairly large “first step” which began between a set of rails in front of the car. To reduce the height of that first step and to eliminate the potential for tripping over the rail a small 3’ x 4’ “landing” at the base of the stairs was constructed. Two 4” x 6” x 4’ beams on the ties between the rails at the base of the stairs.

Wooden platform installed between the track for safety.

We first had to find and cut suitable surplus wood for the project. Once this was done the wood was brought over to the car and carefully set between the rails. Each of the beams was secured to the ties using lag screws to ensure that they stayed in place whenever someone stepped on the landing.

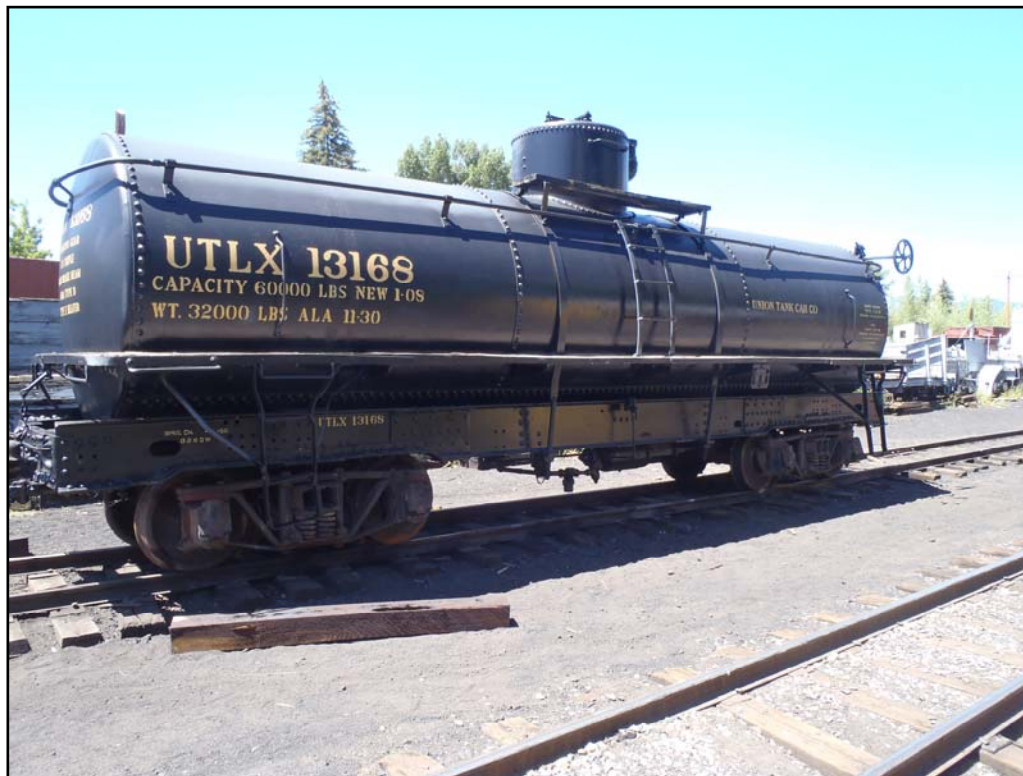
Archbar trucks have replaced the Bettendorf trucks on UTLX 13168

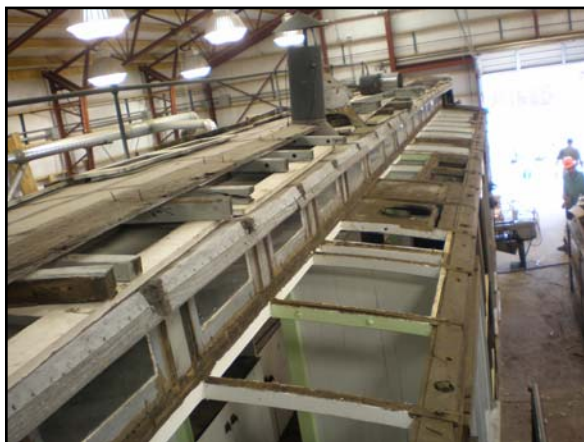
Rotten wood under the tin has been removed.

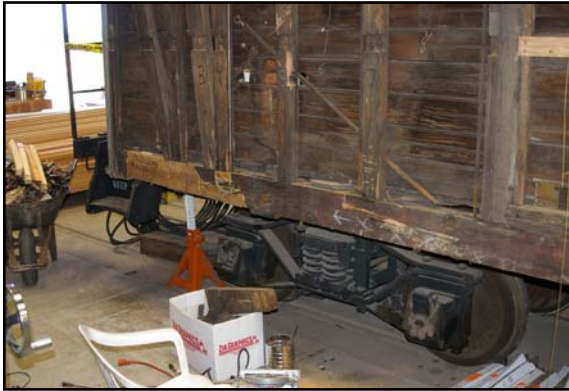
**Session C:** Replaced approximately 8 foot chunk of the outside sill (A end of Car) with new laminated beam. This involved prying the upper portion of the car loose (i.e. raising the tenons above the mortises) this was accomplished with a 20 ton hydraulic jack. This was required as the new section of beam was to span the steel bolster. The new sill piece was epoxied in place, end

Layout of sill replacement.

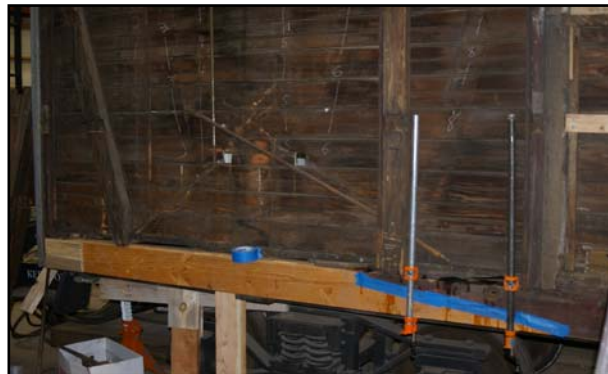
New sill section in, end sill repaired, epoxy

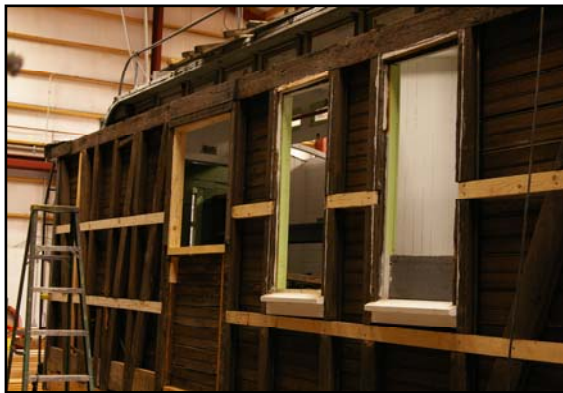
Jim and Warren made new jambs and casing for the four remaining windows. These windows had been previously replaced and were not level, square, or level to one another. The window guides were also not deep enough to accommodate the new siding that will be installed. These windows now have new sills, new jambs, new guides and some new interior casing.

Old windows removed, note sill at differing heights.

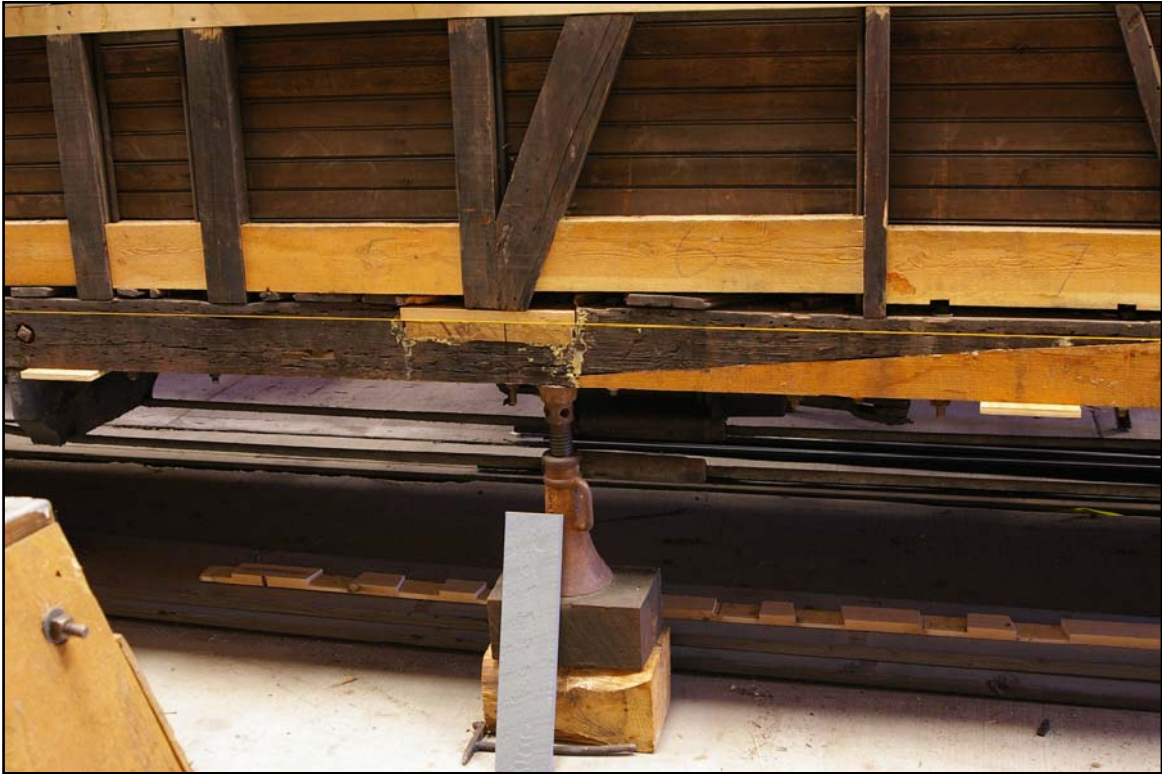
All carlines were installed except for 1 full width beam for the A end of the car, which still needs its inside edge chamfered. (no router bits at the CRF and the borrowed one had gone home) Lastly the center of the car was jacked up and prepared for a steel plate to be installed spanning an area with two repairs that have weakened the sill. The steel has been marked for drill, but not yet installed.

Area to be reinforced with steel on inside of sill.
