OIL HOUSE BRICK POINTING

CONVERT CAR 05635 TO CABOOSE

PIPE TRAIN IDLER CAR

BOXCAR 3553

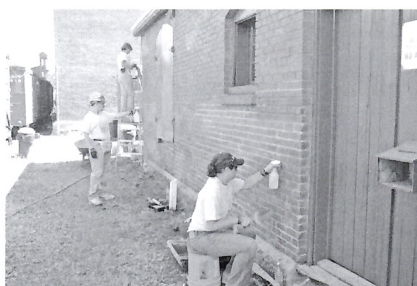
Colleen Wilson, Mathew Eskender and Laura Eskender pointing brick on the Oil House.

A "recipe" was created for the mortar mix used on this project. It includes very fine screened cinder to give it a darker color when dried to blend in with the existing mortar. The same process that worked well in 2004 was continued in 2005. Old mortar that needs to be replaced is chiseled and scraped from between the bricks. Only deteriorated mortar is removed as necessary, leaving mortar that is still good. Cement caulk is applied where needed for deep damage repair prior to applying mortar over the top of it. New mortar is prepared and applied to newly cleaned areas. Excess mortar is best cleaned off with a wet sponge.

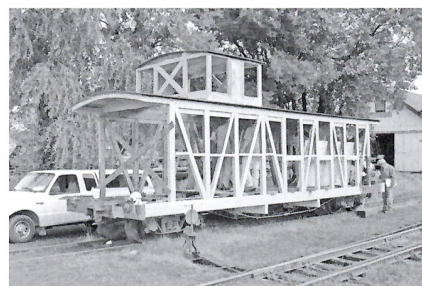
Caboose 05635 ready for siding.

As this was an all-wood car, under today's rules it could not be operated within a steel frame car consist, but always had to be at the end of the train. To provide the railroad with much more flexibility in the use of the car the wooden center sills were replaced with two 4" x 6" rectangular high-grade steel beams. This will allow the car to be used within a steel car consist, not necessarily at the end of the train. Each beam was inserted through the slightly less than 5" x 8" holes in the cast steel bolsters, where spacers, shims, and blocks of steel were welded on top of each beam to prevent any lateral or horizontal movement. Steel cheek plates for coupler placement were fabricated and holes drilled to affix them to the new steel center sills. Brake rigging, air reservoir and other underside parts were reinstalled. Welding was accomplished by John Cole.

Nearly all of the frame was covered with oil base primer as were all sides of the new siding. Three quarter inch thick, mostly clear T & G poplar siding was nailed in place on both sides. The window framing at three locations on each side was sided over

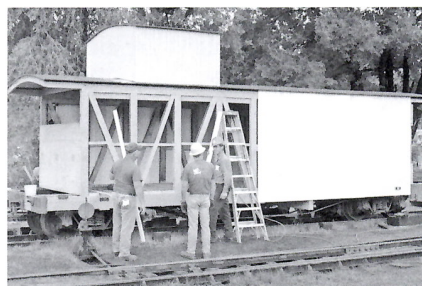
Siding near completion on caboose 05635.

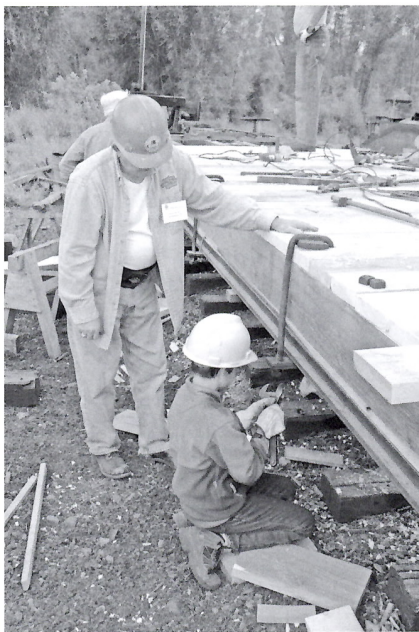
Dave Sands watches as his grandson, D.J. Sands, tightens a U- bolt on the idler car.

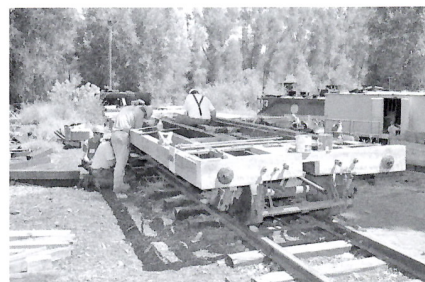
Pipe train idler car near ready for decking.

Structurally, the needle beams were determined to need replacement so the team made new needle beams that were exact copies of the originals. The plumbing underneath the car was removed, the new needle beams were installed, and the plumbing was replaced.

In session F the stiffeners were reworked into the floor decking as on the other cars. The second intermediate sill, drive sills, and end sills were replaced. All hardware was reinstalled along with a new deck. A coat

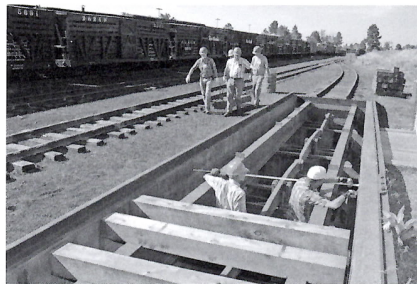
The miscellaneous repairs team sets ties on the scale in preparation for temporarily covering the pit.

As a temporary safety measure the open scale house pit was covered with plywood, nailed to ties placed on the scale frame work. A mixture of linseed oil and paint thinner was applied to the walkway and hand rails of the Chama bridge.

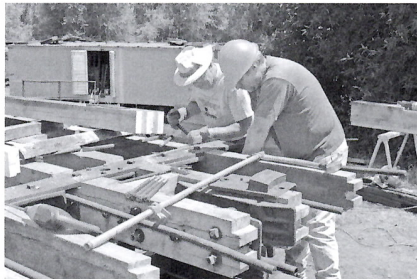
Dan Robbins and John Ruhr working on sill of car 3553.

major task was removal of the Murphy roof. The team documented its methods for removal. Upper sills had significant water damage and new sills were fabricated. Lower sills also required replacement due to water damage, primarily resulting from water leakage at the windows that were installed when the boxcar was converted to a concession car. Several panels of the Murphy roof also need to be replaced due to rust. Replacement parts are available.

Session D work included installation of the upper and lower sills along with vertical and angled tie rods on one wall and installation of the lower sill, vertical members, and tie rods on the other wall. The second upper sill was ready to install. Four sidewall vertical posts and four door points were fabricated from scratch. All vertical tie rods were cut and threaded and angled tie rods were welded together from old rods and threaded.

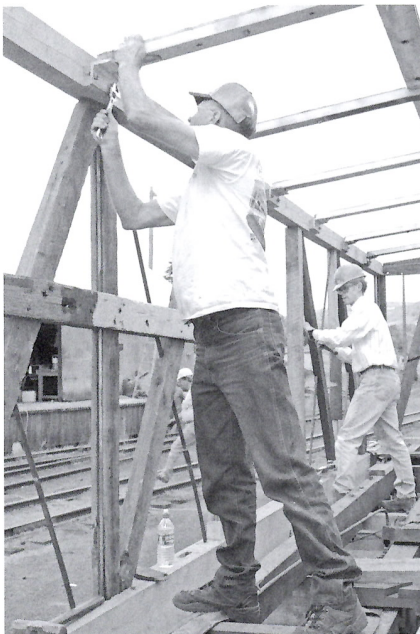
Bob Lenicheck and Wendell Schweitzer setting roof ribs on car 3553.

The Session E and F teams fabricated and installed new end sills. Framing of both walls was completed. As many diagonal truss rod castings as possible were salvaged. New diagonal truss rods were fabricated as needed and truss rod installation was completed. Roof rafters were installed. Wall studs, truss rods, and end rafters were installed on both ends. The belt line was installed around the car using some old pieces and fabricating some new pieces. Installation of the wood roof and exterior end siding was

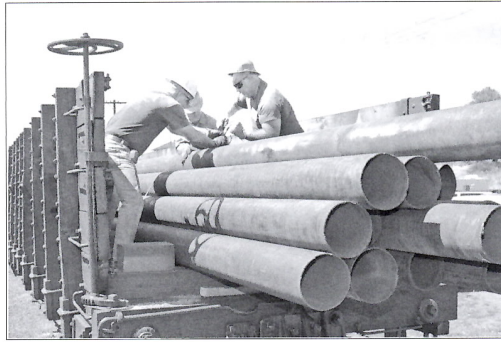
Jim McGee, Michael Camara, and Bob Michel strap down pipe in the display gondola.

Pipe gondola 1557 was loaded. Four 4x6 blocks were used full width on the floor to support the load. The pipe was loaded with a fork lift and laid in the car in a pyramid with six pipes on the bottom. The pipe was banded together in four places. Three chains were also put around the pipe and anchored to the floor. For security reasons, the chain was bolted to the top pipe with counter sunk allen head bolts held with Lock-Tite. The "S" hooks were welded together on the bottom and the chain also was welded together in two places.
