## **Job 1161 - Trash Removal - Antonito**

**Job 1162 - Rebuild GON #783**

## Job 1167 – “Box” 3 High Valve Cars

**Job 0760 – Scale House - Miscellaneous Structural Repairs - 344.280**

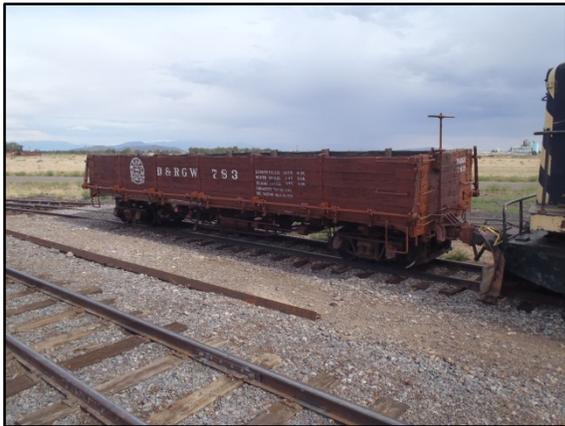
Car on arrival from Chama.

I noted evidence of structural damage to this car while it was still in Chama and discussed it with Marvin, before the car was moved. While moving the car to the Antonito CRF, the train crew noted frame flexing in the suspect area.

Visual inspection of the car in its present partially torn down condition revealed that the wood beam that fits inside one of the C channels in the suspect area has rotted completely through. I feel that once we get this area completely cleared out, we will also find the C channel cracked, or even rusted clear through

**What additional work is required?** The first phase of work will consist of continuing “tearing down” the car. All cross frames and both bolster saddles must be removed by cutting their rivets with a gas torch or an air chisel, then the center section wood beams must be removed.

After the tear down is completed, the center section “C channels” must be sand blasted, so that “eyeball inspection” can find visible damage and the “Dye Check” process can be used to inspect for cracks around the cross frame attachment holes. The cross frames must also be sandblasted and dye checked around the attachment holes.

Once the damage and cracks are found they will be repaired by welding. The channels and cross frames will be “Red oxide” coated, new wood preservative treated wood beams will be installed, and the cross frames reinstalled with Huck bolts.

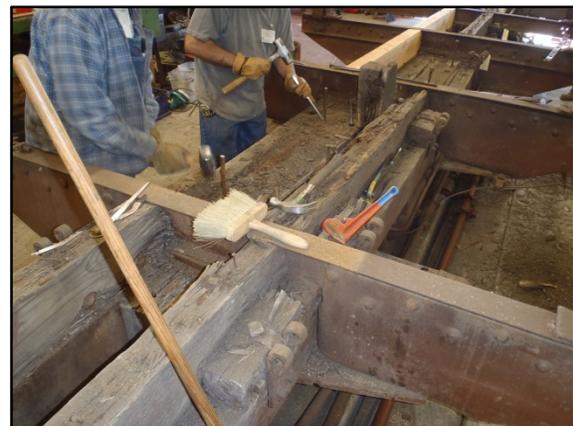
Teardown well underway.

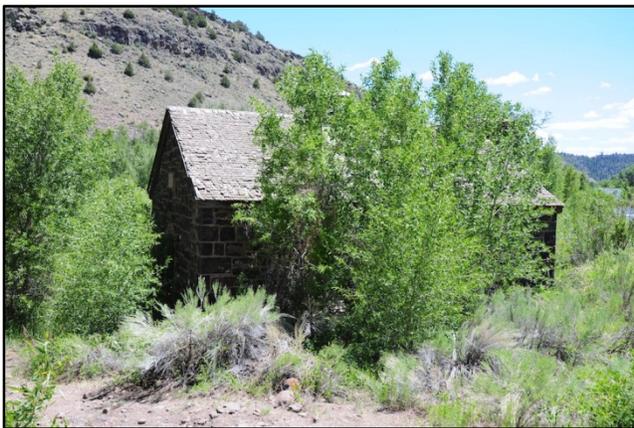
North side before brush removal.

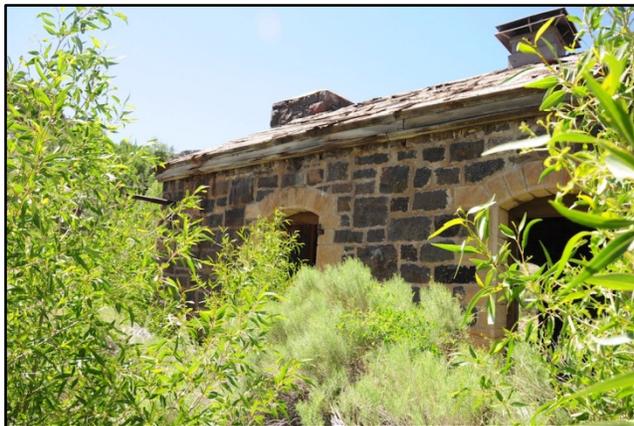
South side before brush removal.

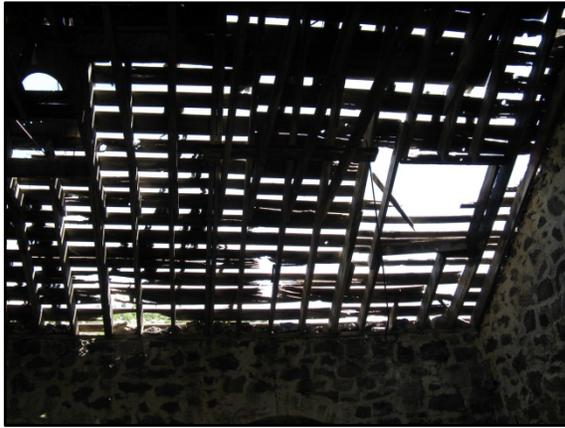
South side of the roof.

**Project Status:** If the brush pile we left in June was chipped and shredded in August, then the site is ready for roof and/or repointing work. At this point, both of these projects depend on input from SHPO. Roofing options include replacing the present deteriorating shake cedar roofing with new shake roofing (similar to what was done with the log bunkhouse in Chama) or removing the present roofing and installing a steel frame superstructure that both outlines the historic roof and also stabilizes the structure’s masonry walls. Repointing depends on SHPO’s analysis of the mortar samples we provided. Based on their findings, some research will be necessary to see if the mortar can be reproduced by a present day roofing supply company.

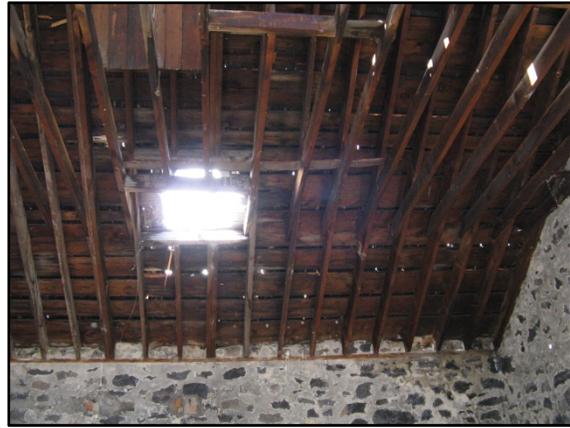
North side of the roof.

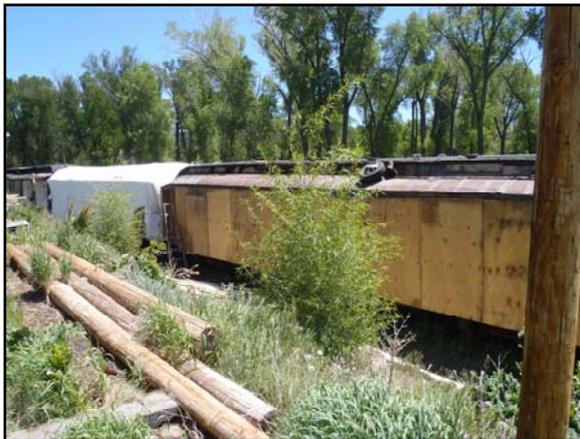
**Work Accomplished:** I succeeded in paneling 0452 and 065 (except for the door end on 065). I put the rubber roofing on 0452 that came from the car in Colorado Springs. To manage the membrane I had to cut it in 4 pieces and then over lap the pieces as I placed them on the roof (about 1-1½ feet), starting at either end. There were various holes in the membrane. There was one sizeable tear in the north end section that needed to be over lapped 5-6 feet to cover it. For the final section in the middle of the roof I used the remainder of the membrane left over from caboose 0503. The membrane was secured to the car by nailing furring strips to the membrane edges below the top edges of the plywood. I didn't have any adhesive so the lap joints are not sealed and no patches were applied to cover holes/tears --- it's not water tight!

Plywood siding completed on #0452

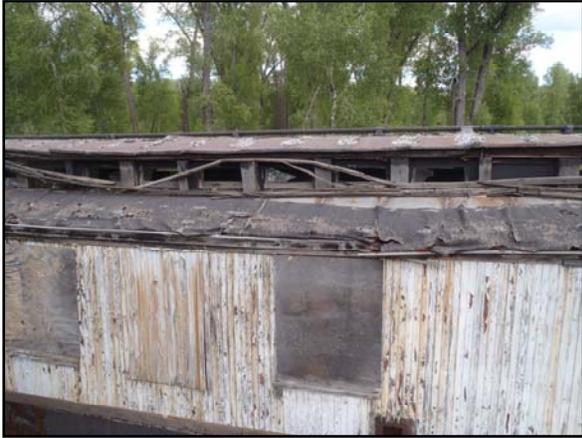
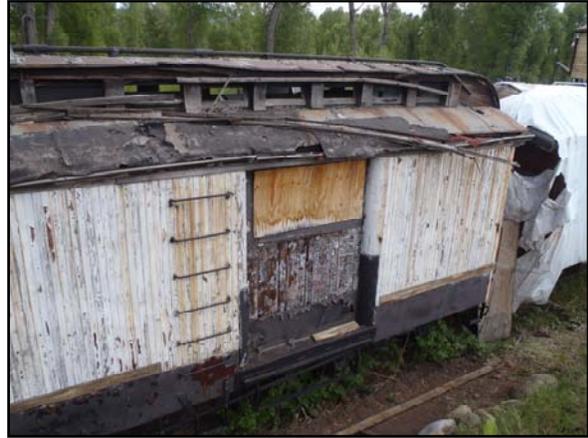
I did not attempt to work on the roof of 065. It needs to be cleaned of debris (old roll roofing, loose molding, nails, etc) and then prepped for the rubber roofing to be applied (sharp edges smoothed/covered, conduit on top removed or ramps built for smooth transition for the membrane to lay over, etc). Also the door end still needs to be paneled in. Again like 0452 it is not water tight either.

Shows roofing material that needs to be removed or flattened and rounded so as not to tear and rip the roofing cover when applied.

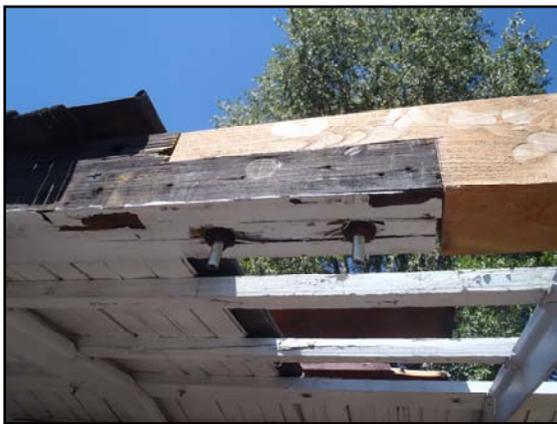
New header has been spliced in the middle of the car.

**Work Accomplished: Session E.** Prepared new 4" X 5" top plate on east side of the car to replace deteriorated section over the door. Cut to length, cut half lap (12") at each end, and put 10 degree angle on top surface. Chopped mortises for posts and cut dadoes for roof carlines in top plate. Installed plate with four (4) 7" X 1/2" carriage bolts and attached the roof carlines with five (5) 7" X 1/2" carriage bolts. Made new 3/4" X 94" rods and placed along the door posts. Removed the old roof boards and milled replacement boards using 3/4" X 4 1/2" T&G.

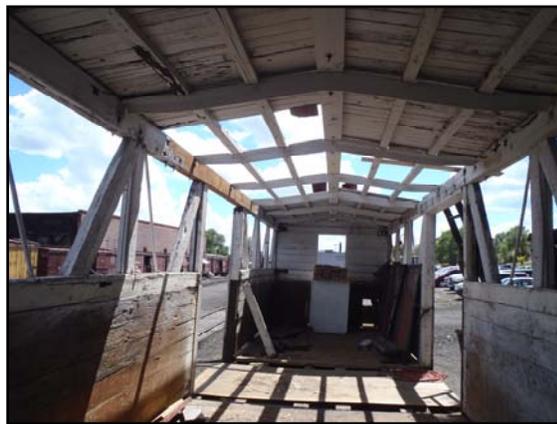
Rotted roofing has been removed.

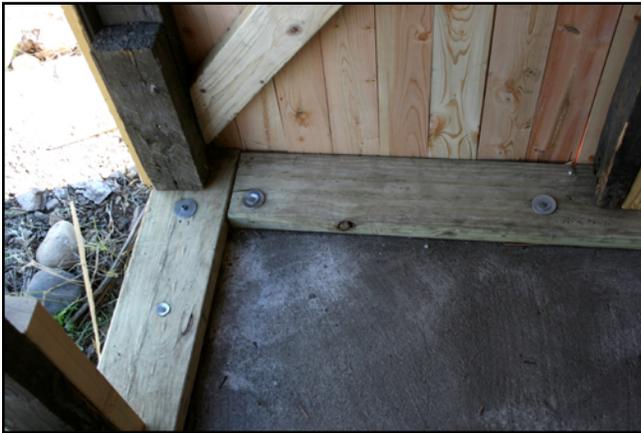
Floor sills have been replaced and secured with concrete nails

**Work Accomplished:** On all 4 walls, rotted 2x6" floor sills were removed and replaced with pressure treated wood boards which were fastened to the concrete floor slab with a ramset power gun and nails.

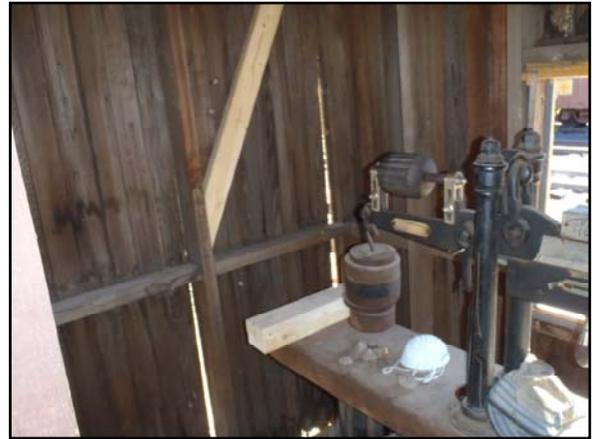
Cross bracing being installed on the interior walls

On all 4 interior walls, 2x4" cross bucks were installed to support the structure's walls. At the base of each existing building framework 2x4", a "sister" or "scab" 2x4x18" was nailed and attached to the new pressure treated wood floor sills.

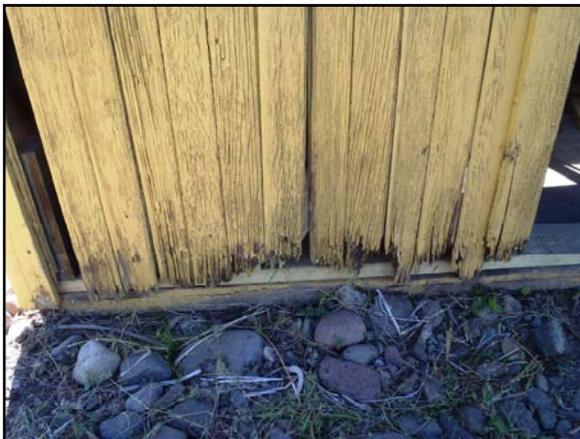
Old rotted siding before it was removed.

The north, west and most of the east wall's outside siding was removed and replaced. **(NOTE: there was not enough good or new siding to replace the south wall which STILL NEEDS TO BE REPLACED in a later session.)**

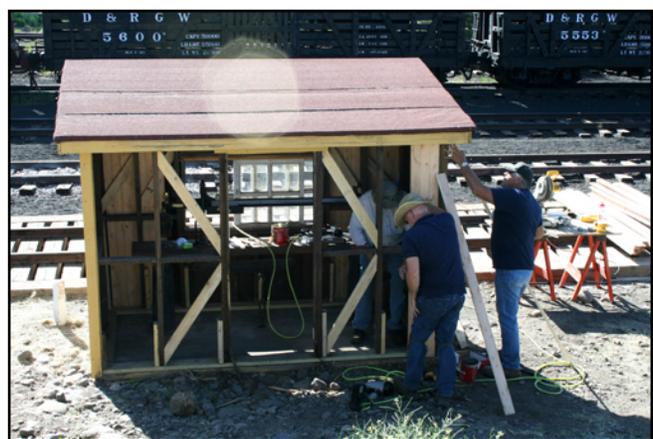
Tongue and groove siding is being installed on the west wall.

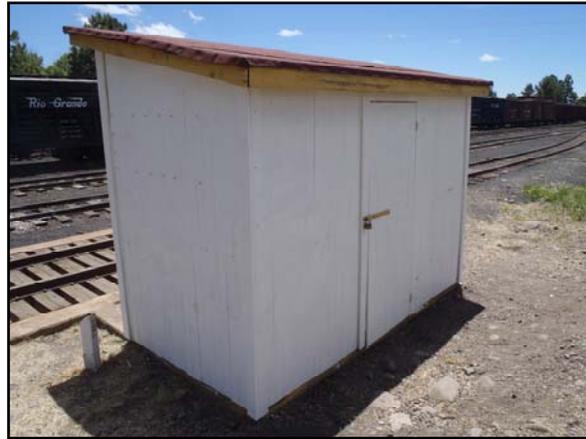
Shows the new door on the west side.

A new door made from new tongue & groove siding was made and installed on original hinges. The original door knob and latch was given to Bill Mackey to repair (the latch was historic rather than functional.) The original locking hasp was reinstalled so the door could be locked.

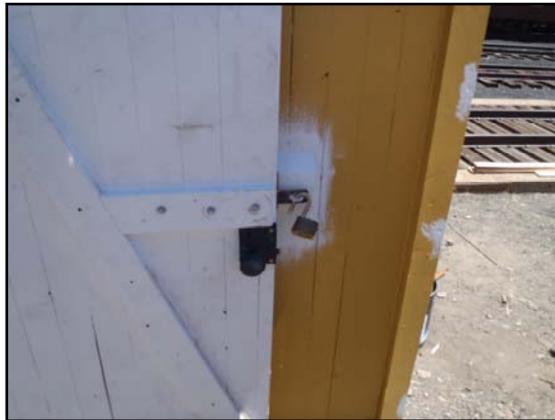
The hinge and hasp have been re-installed.

**Project Status: Not Completed** - The entire south wall which is very rotted at the lower edge, need to be replaced with new siding as moisture and animals are able to enter the structure. The hinges and hasp hardware needs to be **reinstalled** with bolts and not screws to prevent unauthorized entry. (None were available on Saturday when installed.)
