# C&TS Dispatch

FALL 2007

## HISTORIC PRESERVATION – 2007

*The June Volunteer Work Sessions*

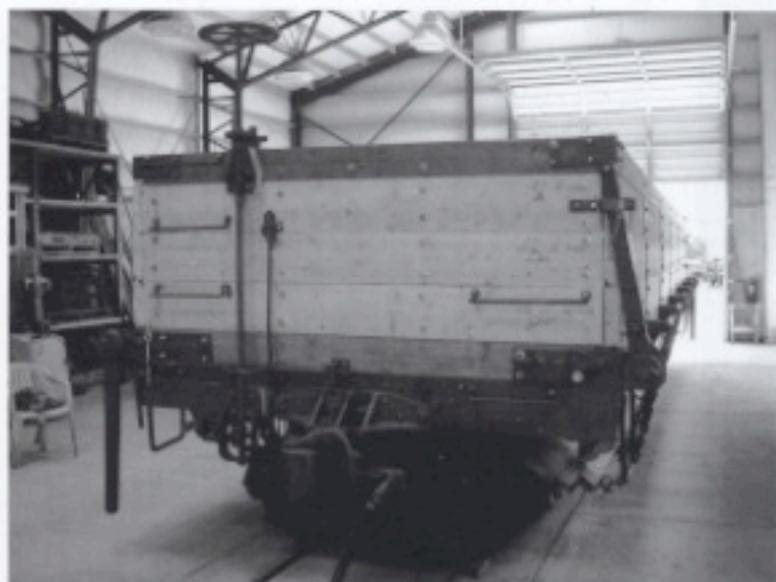
Following significant progress during the 2006 work sessions, all restoration work on drop bottom gondola 859 was completed during Session C. The team installed the end siding, the brake staff, adjusted the drop doors, installed the remaining safety equipment, and gave the car a coat of linseed oil. The car is finished except for painting and lettering.

*Completed drop bottom gondola 859 in the Antonito CRF. (Bill Pratt)*

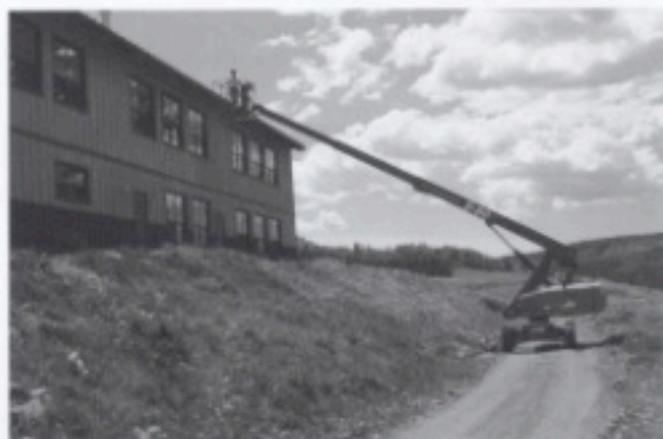
*Clyde Putnam works from the self-propelled man-lift. With a 60-ft reach it allowed greatly improved access for painting the Osier Dining Hall. (Scott Hardy)*

The entire north wall (kitchen end, nearest the water tank) was pressure washed, primed, and painted yellow/gold with brown trim. Likewise the portion of the opposite, south wall, that had not been painted in 2006 was washed, primed, and painted. Some trim on the east-facing upper story windows was painted or covered with a second coat. Roof trim around the entire building was painted brown or repainted as necessary. Touch up painting was done in a few areas around the building

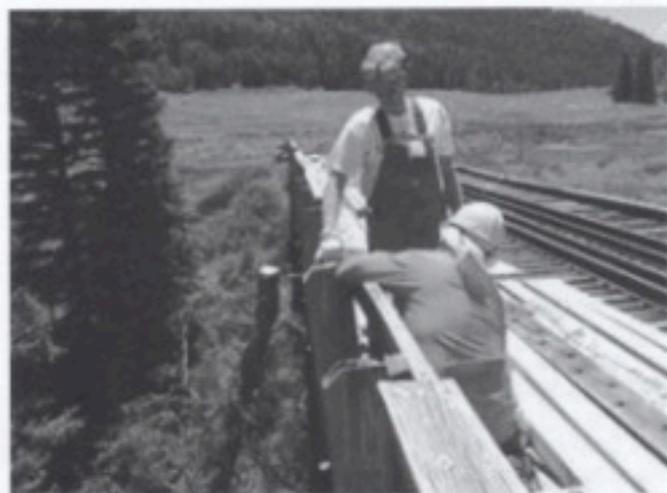
Most of the handrail boards were warped and about 25% were split or decayed. All sound but warped boards were forced into alignment with clamps and nailed into position, and defective boards were replaced with new ones. The process of drawing all handrails and posts into close contact and securely nailing them greatly reduced the flexibility and deflection in the walkway/handrail system.

The vertical posts and diagonal braces are susceptible to decay due to their design. Five of the 51 post/diagonal brace assemblies and one diagonal brace had to be replaced. Posts 1, 2, and 3 (posts are numbered from the Chama end of the trestle) could be reached by standing on the ground on the west end of the bridge and their replacement was straightforward. Posts that could not be reached from the ground were removed and replaced from the walkway as an assembly. The bolt between the diagonal and the post, at the bottom of the post, was too far for a person to reach while

*Mickey Hallum and Bob Reib repairing the Lobato Trestle handrail. (Mike McGinley)*

The repairs conducted in this session are not a complete rehabilitation of the bridge walkway/handrail, but merely a correction of immediate safety conditions. In order to plan future repair efforts, the team conducted a survey of all of the posts and diagonals. A few are recommended for replacement in 2008, and some of the others need to be replaced by 2009 or 2010.

lying on the walkway, so the assembly had to be removed and replaced as a unit. This difficult operation required all four members of the team. The post/diagonal brace assemblies weighed between 110 and 130 pounds. Precautions were taken to secure clamps and wrenches with lines so that they could be recovered if dropped.

In addition to the walkway repairs, the team also cut back a leaning tree that was a potential threat to the walkway. The team strongly recommends that this tree be completely removed because it remains a threat to the trestle structure.

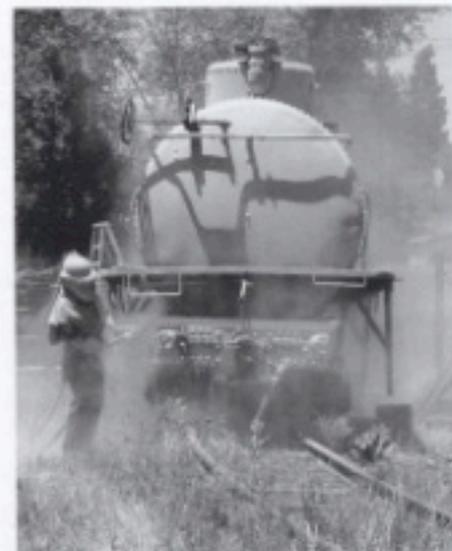
*Clark Bradley is sandblasting the B end of UTLX tank car 12961. (Sandy Hogan)*

The cars were completely sandblasted to achieve an acceptable surface for painting. The cars were then primed and finish coated.

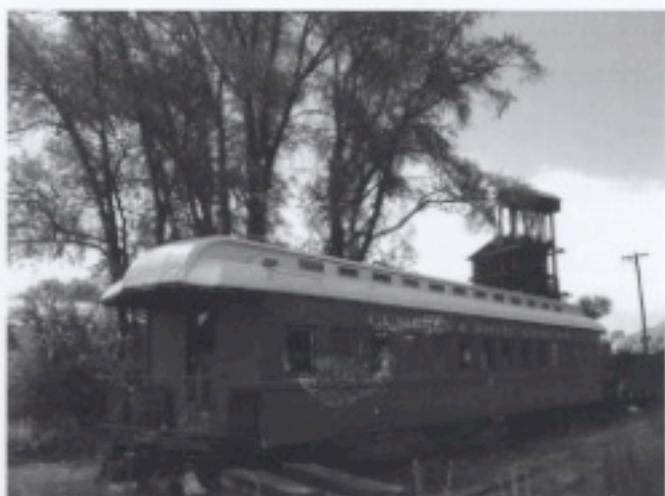
Therefore, work focused on repair of the roof, which had been leaking. Chama recently had experienced very strong wind and the Hinman car had part of its canvas roofing blown loose. It was apparent that the roof needed more extensive repairs than initially thought; in fact, it needed to be replaced to prevent further damage. After much research it was decided that replacing the roofing with the same canvas material made little sense. It would need to be re-treated with waterproofing annually or every other year at best. After thorough review of the benefits, it was decided that a neoprene underlayment known as EPBM would be the best roofing to use on the Hinman. Materials were ordered prior to the work session. The Hinman was moved to a location in the Chama yard where scaffolding would not interfere with daily movement of locomotives and cars on or near the main line. Scaffolding was erected along one side of the car. Four of our crew unloaded the roll of EPBM, contact adhesive, and heat reflective paint and placed it on a flat car near the Hinman, while part of the team began stripping off what was left of the canvas roofing. This exposed many areas of rusted metal that had been leaking water into both the interior of the coach as well as down through the sides of the car. It was determined that this leakage was what had been causing the lower body of the car to rust. Once the roof surface was scraped and wire brushed clean of tar, old canvas residue, and flaky rust, the larger rust holes were patched with caulking and Bondo.

Hinman coach with new roof. (Phil Nissen)

The roofing was entirely replaced and coated and should last indefinitely. No subsequent maintenance should be required, although the roof should be inspected at a future date to make sure no sections are coming loose and that no water or ice is getting underneath. Some caulking around the roof jacks and tank hangers would be beneficial along with a bead of caulk applied to the seam where the roofing butts the clerestory windows as extra prevention. There are also at least three cracked clerestory windows for which replacement glass had already been cut. However this project had to focus on the roofing and did not have time to address windows. They are not leaking and are not a glaring defect in the appearance of the car at this time.
