Fairmont Speeder

MAINTENANCE-OF-WAY

STRUCTURES

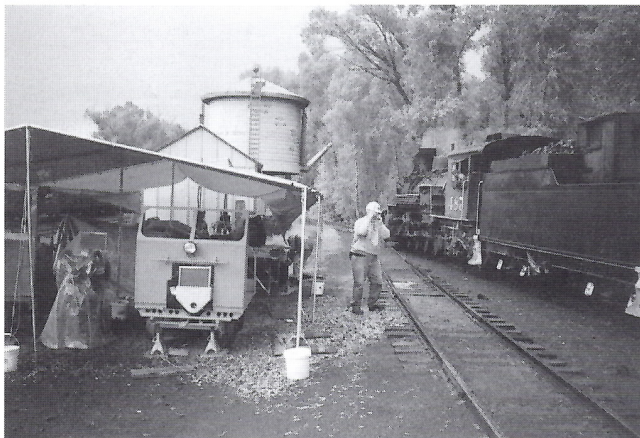
The Fairmont speeders being restored during session C; locomotive 487 switches cars in the north end of the Chama yard. (Photo by George Swain.) Below, the Fairmont speeder takes to the rails in Chama after rebuilding. The crew built a turntable to move the speeder on or off the rails. The new speeder shed is to the right (session D).

sessions. The team has restored D&RGW narrow gauge motor cars 04 and 013 to operating condition. The project involved the installation and testing of many systems and subsystems. Work completed during session C included completion of chassis assembly, gauging of wheel sets, and making final installation of brake rigging and brake levers on 04 and 013. With the exception of mounting the engine, work on 013 paralleled that on 04 (mounting the 013 engine was more complicated than expected). Before session D was over, both motor cars were tested. 04 ran smoothly, reversed easily, and demonstrated that it could pull a load when it towed 013 from one end of the yard to the other. Because of problems with timer and throttle controls, 013's engine didn't perform at its optimum level (these problems were addressed in session F in August). The team will letter the motocars in May 2004 and apply a series of plates providing maintenance and operating instructions.

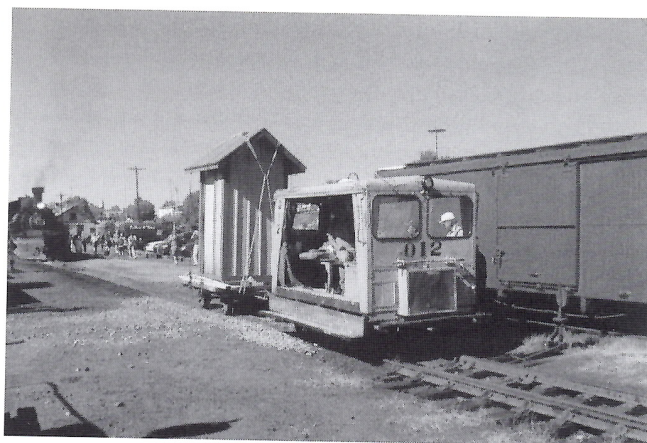
In Chama the rebuilt Apache Crossing telegraphphone booth ready for the move to its original site (session E).

The Apache Crossing telegraphphone booth, which was rebuilt and painted last year was replaced at its historical location on the right-of-way. The team brought the Rock Tunnel booth east of mile post 315 to Chama for repairs on the last day of the August work session. The Bighorn telegraphphone booth, which vandals turned over and rolled down the hill during the summer, will also be brought to Chama or Antonito when the railroad crew has an opportunity to obtain it this fall.

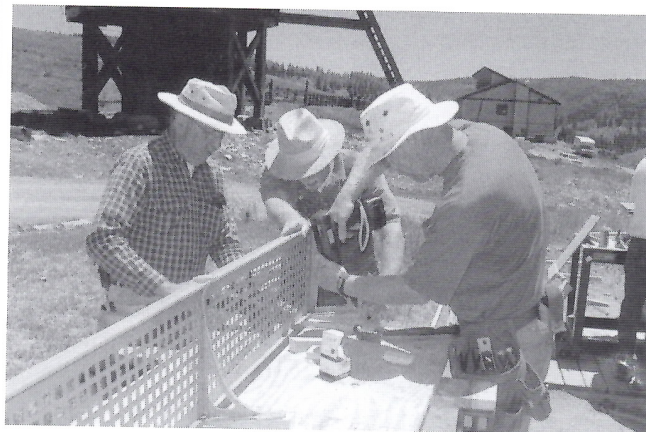
At Osier during session D, Dan Robbins (l), Dave Hoyt, and John Ruhr mount a luggage rack that will be hung in the section house.

work done in 2002 at the site because of the forest closures, so the team was glad to be back. The section house is very near completion. The team finished painting the interior of walls, doors, and window frames and finished building over one-half of the kitchen and bathroom cabinets. Next year the

team will finish cabinets with tile counter tops and back splashes, paint window mullions inside and out, build and install transom windows over A and B main doors, install interior door hardware, and attach bath and kitchen towel bars. Osier station work included finishing all downstairs interior woodwork, ceiling, and all trim including windows, doors, and stairs. Upstairs the crew installed a safety railing around the stair opening and finished about one-half of the trim work. An 8-x-16-foot porch was built on the rear with stairs and platform hooking it to the handicap walkway. Next year should see two windows installed upstairs along with the balance of trim and part of the interior painted.

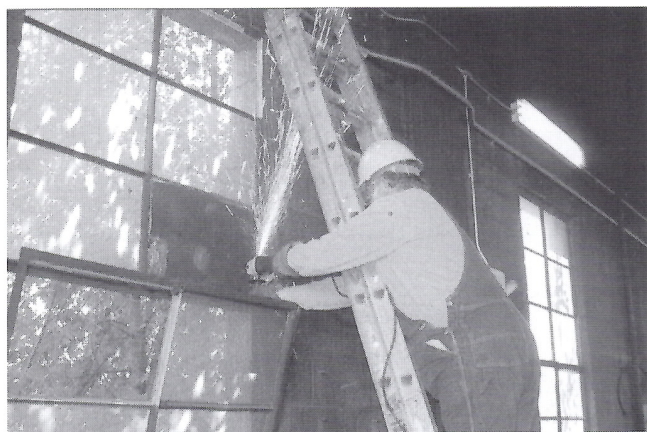
John Manion grinds welded plate from Chama engine house window in session F. Many windows in the engine house were replaced during the August sessions.

There were four major projects tentatively scheduled for 2004 that were undertaken during August because enough volunteers were available and materials could be acquired rapidly. The first project was replacing three broken windows in the scale house south of the Chama depot. The team also replaced thirteen broken or missing panes in the engine house. This involved several days of broken glass removal, careful cleaning of the steel frames, and inserting new glass with a considerable amount of glazing compound. One large pane with a hole through it, located in the upper west side of the engine house, was not replaced. Replacement would have required the use of a basket on the fork lift, movement of shop equipment in use, and a general disruption of important locomotive repairs.

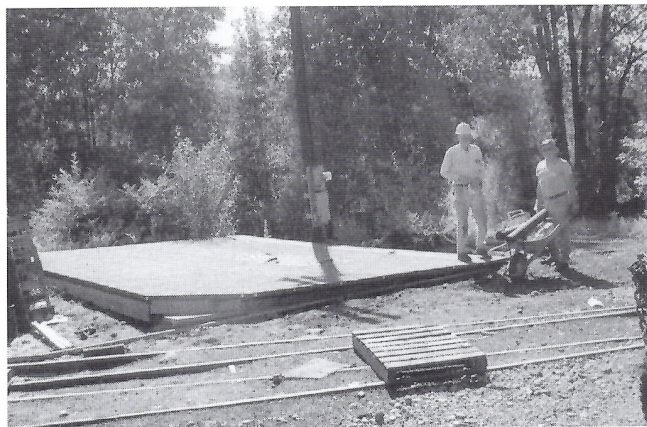
The new cistern cover near the Chama engine house (session F)

The third 2004 project finished this year was in the Chama yard. The cover over the regularly used cistern near the northeast corner of the Chama engine house was becoming a safety hazard, especially for employees who frequent the area, because of the deteriorated wood structure covering the cistern. This large cistern, which was constructed soon after the roundhouse, is essentially round, but flattened on the north side where the roundhouse concrete foundation was used as part of the wall. In August volunteers rebuilt

the 17-x-20-foot wood structure. The cistern is filled from the Chama River from a pump located in a structure near the river and below the southeast corner of the engine house.

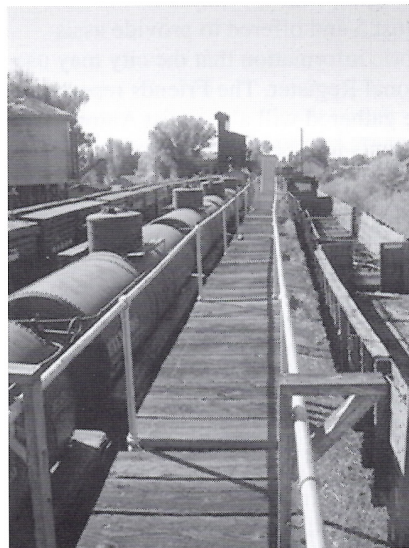
The second project scheduled for 2004, but done this year, involved a dangerous walkway. Nearly all wood decking on a walkway several hundred yards south of the Chama engine house and immediately west of track number 5 was missing or in very poor condition, creating a hazard for railroad personnel and a few visitors who venture along the tracks. The volunteers repaired the 4-foot-wide, 38-foot-long walkway and installed a wood guardrail along the walkway.

New wood decking and guardrail on the oil storage walkway.
