## Job 1121 - Rider Gondola Refurbishment

**Objective:** Refurbish the Antonito Rider Gondola for the railroad.

## Job 1122 - Repair of Car 3669

## **Job 1146 – (MT) Repair A3 Roof**

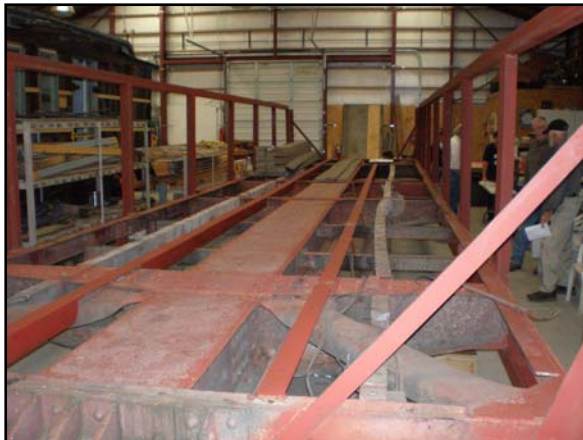
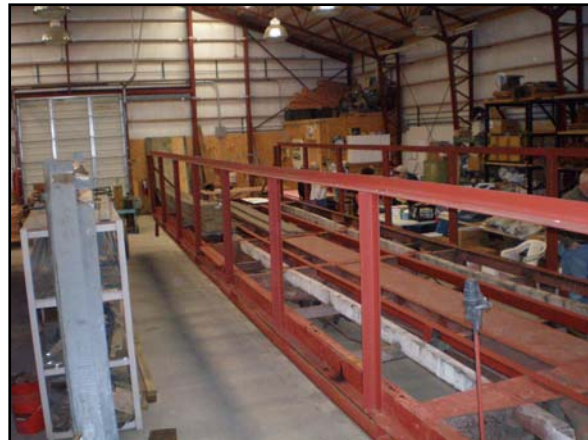
Car at the beginning of the work session.

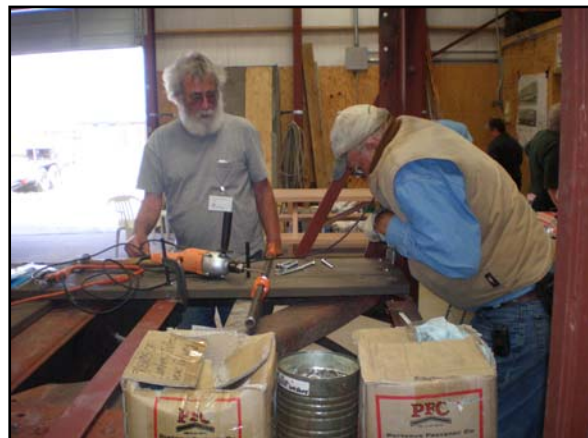
First two TREX boards being bolted down.

Our tasks were to install new flooring, side planking inside the car sides, and rebuild the exterior car sides. The flooring and inside planking are now built of TREX and the outside is vertical siding similar to a traditional box car. Since all the structural elements of the car are steel, every connection had to be through-bolted. This necessitated a lot of drilling through steel. The exterior car siding was screwed into lumber "nailers" or cleats which were through-bolted to the steel upright elements earlier.

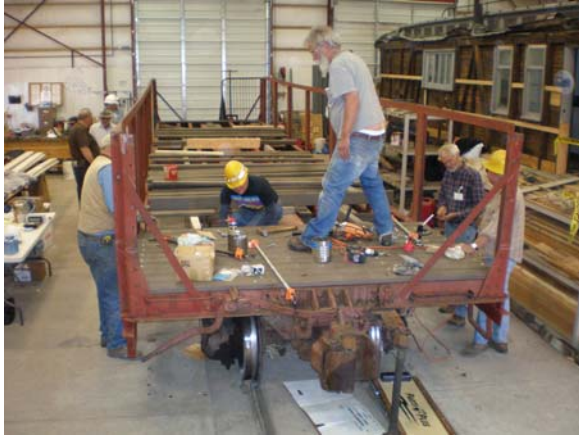
Flooring well underway.

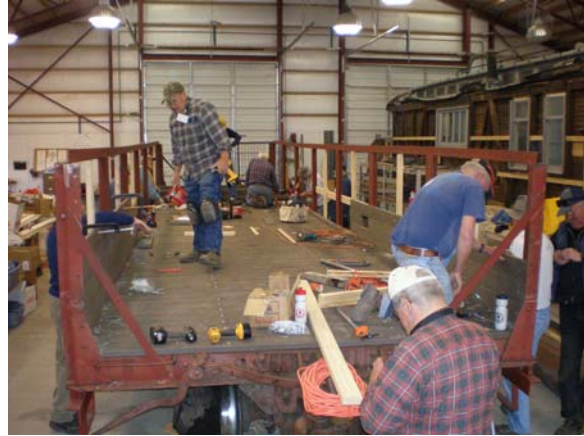
Flooring almost completed.

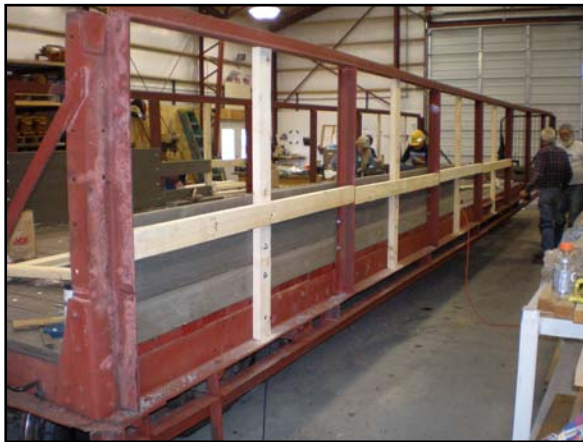
Nailers have been installed.

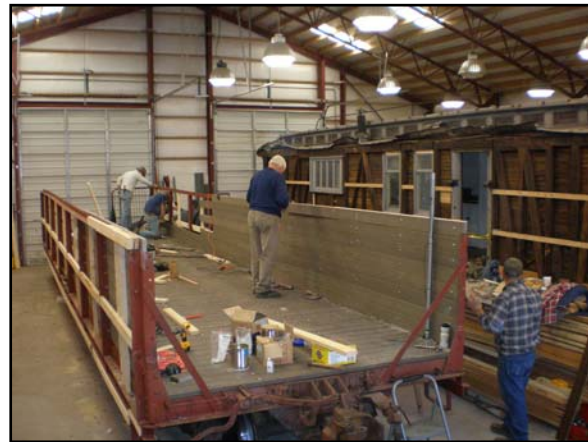
Inside planking well underway.

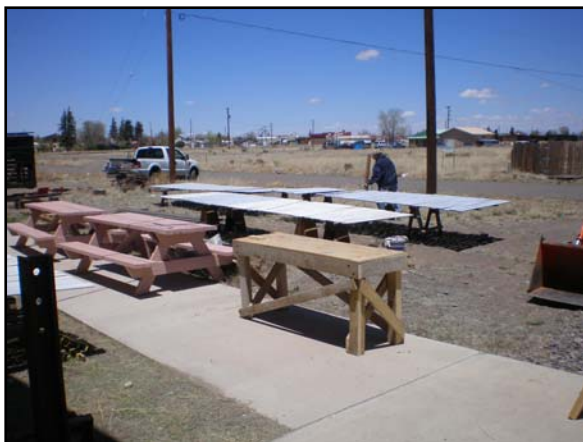
The siding was primed prior to installation.

Finishing the project consisted of reattaching the ends of the car (metal structures/gratings in each corner), the two hinged gang planks, all grab irons, priming and finish painting of all wood. All of the priming (with oil-based primer) was done prior to hanging the siding. Additionally, all of the tongues of the siding were finish painted before hanging so that stripes would not appear as the wood shrinks. Finish painting consisted of three coats of acrylic paint of the railroad's choosing.

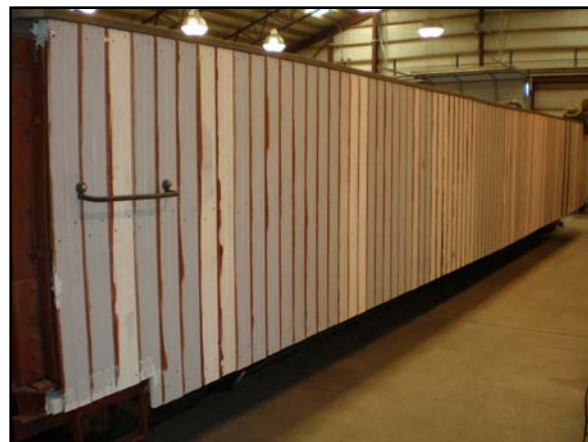
Siding installed. All tongues were painted prior to installation.

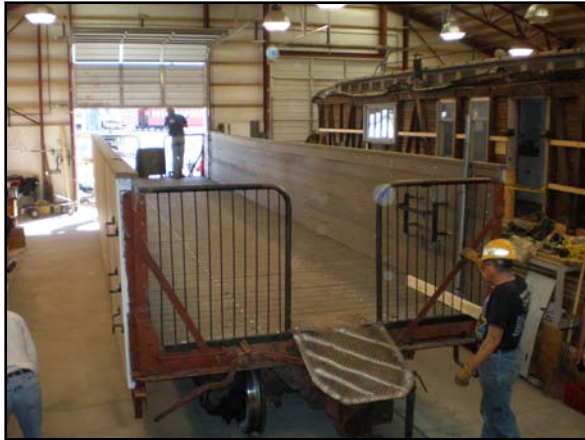
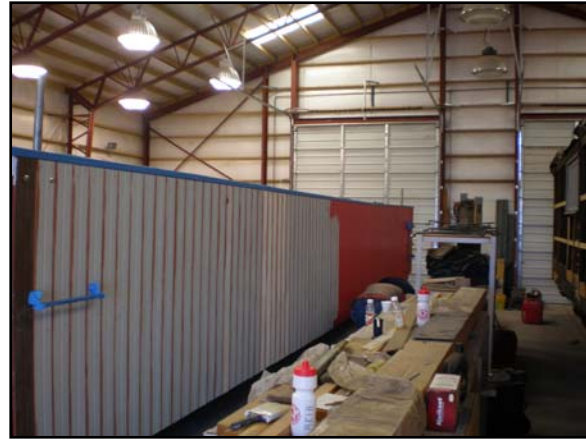
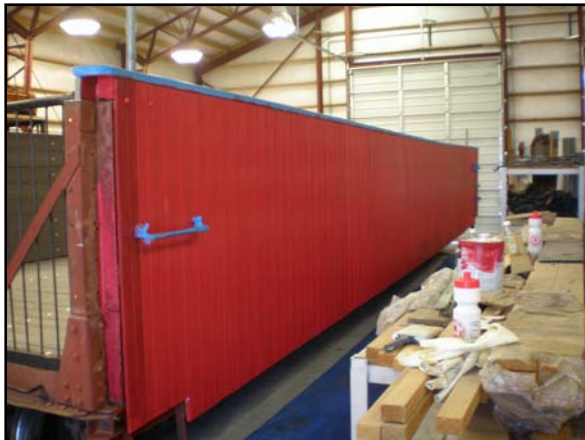
Car after 3 coats of acrylic paint.

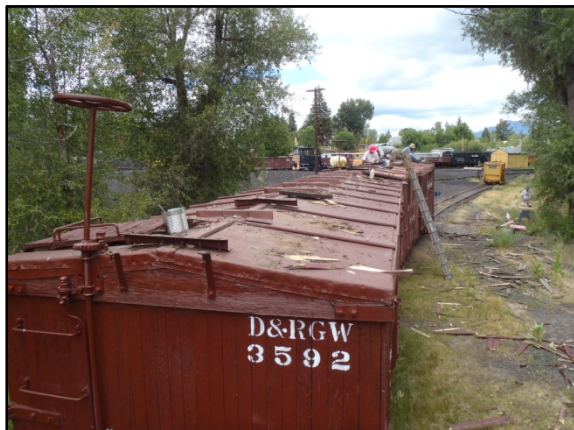
Roof walks being removed from #3592 and #3669.

Specifically, we replaced all the boards (including priming and finish painting all surfaces), rebedded the roof support brackets, and replaced some of the fasteners while reusing many of the existing fasteners.

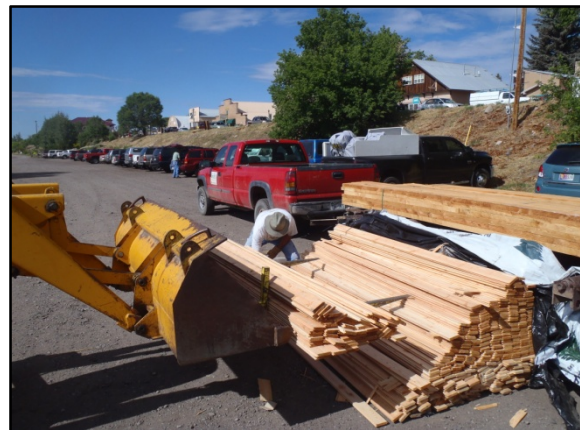
Team Leader Tim Bristow unloads siding. The wood was not beveled as ordered creating a huge problem.

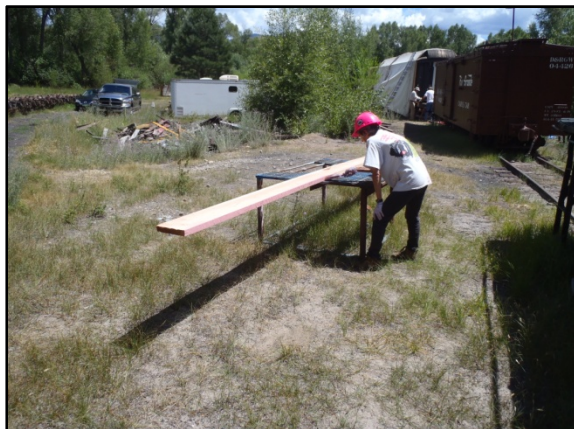
Linda King priming roof walk lumber.

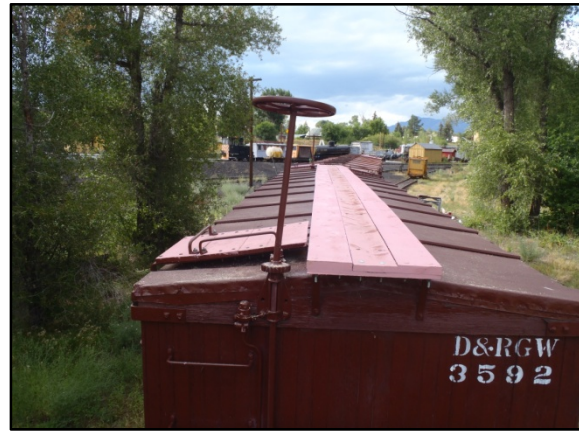
New primed roof walk on car #3592  
Still needs a final coat of paint.

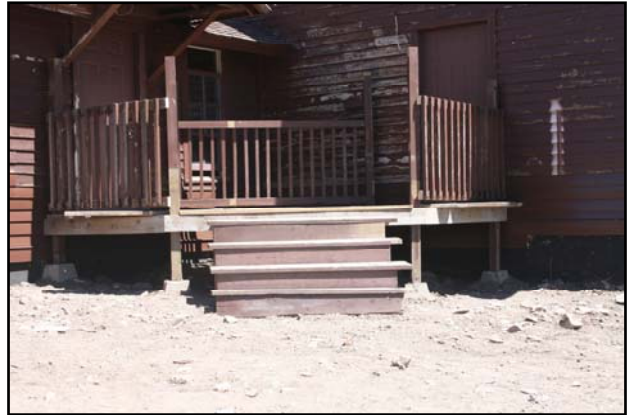
Finished back porch.

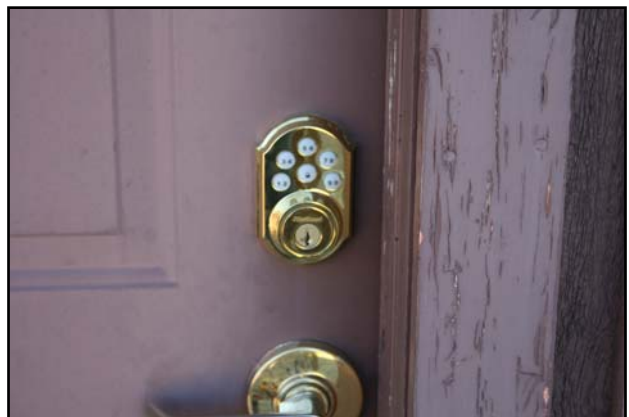
Electronic lock finished on back door.

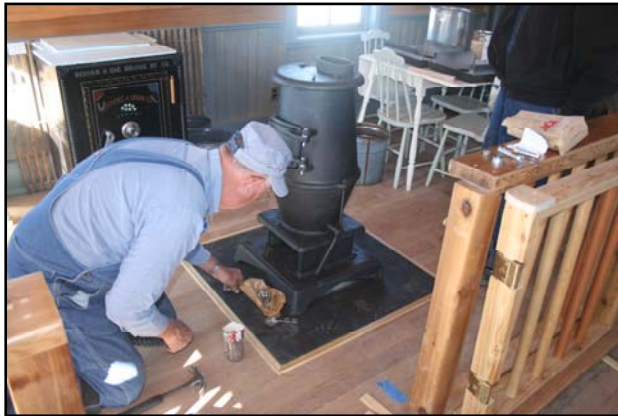
Ron Carder installing stove base in the Depot.

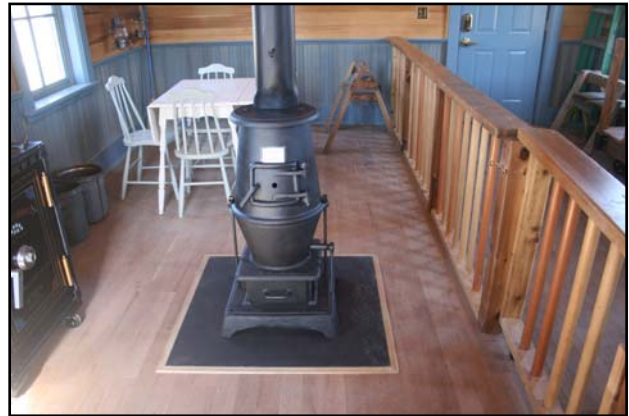
Installation of stove completed.

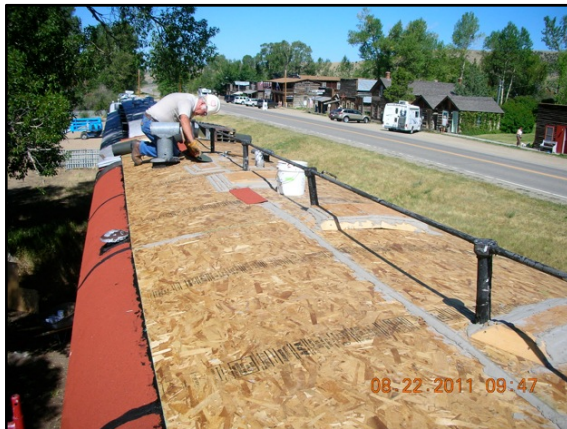
Chuck Deuker working on the A-3 Roof –  
note the raised penetrations covers.

**Work Accomplished:** The roof on A3 was badly deteriorated in several locations giving water free access to the interior. The roof had almost two dozen penetrations which made achieving a water tight roof difficult. We started by peeling off all of the old roofing that would come off easily; this included numerous previous patches made with roofing, tar, metal, and so forth. It was determined that a new roof could not be successfully applied to the existing surface, so the central roof was first overlaid with OSB screwed to the edges. All vents and piping penetrations that could be easily removed were, and many of the others were boxed over with wood so they would not penetrate the roof. About a dozen could not be removed, so they were roofed around and thoroughly sealed. The ends of the roof were originally covered with copper, which appeared to be in good condition so it was not disturbed.

The roof was first covered with a tear resistant felt substitute then 60lb rolled roofing material. All of the seams were sealed with roofing cement. Once the rolled material was in place, the roof was painted with silver roof coating. One small area on the top was left unpainted because we ran out of coating and the nearest coating was in Bozeman. The unpainted area was pointed out to the MHC with a request that they complete the job.

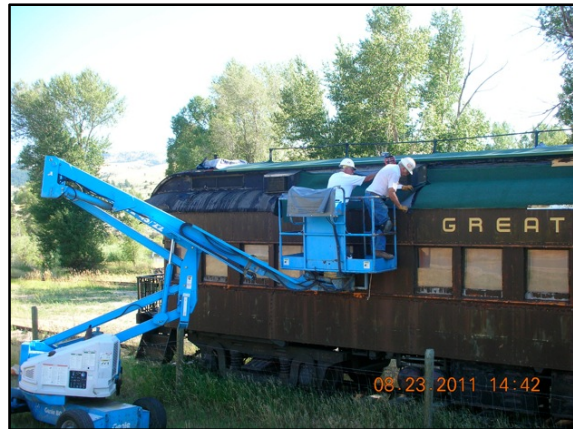
Chuck Deuker and Tarry Rahne putting  
rolled roofing on A-3

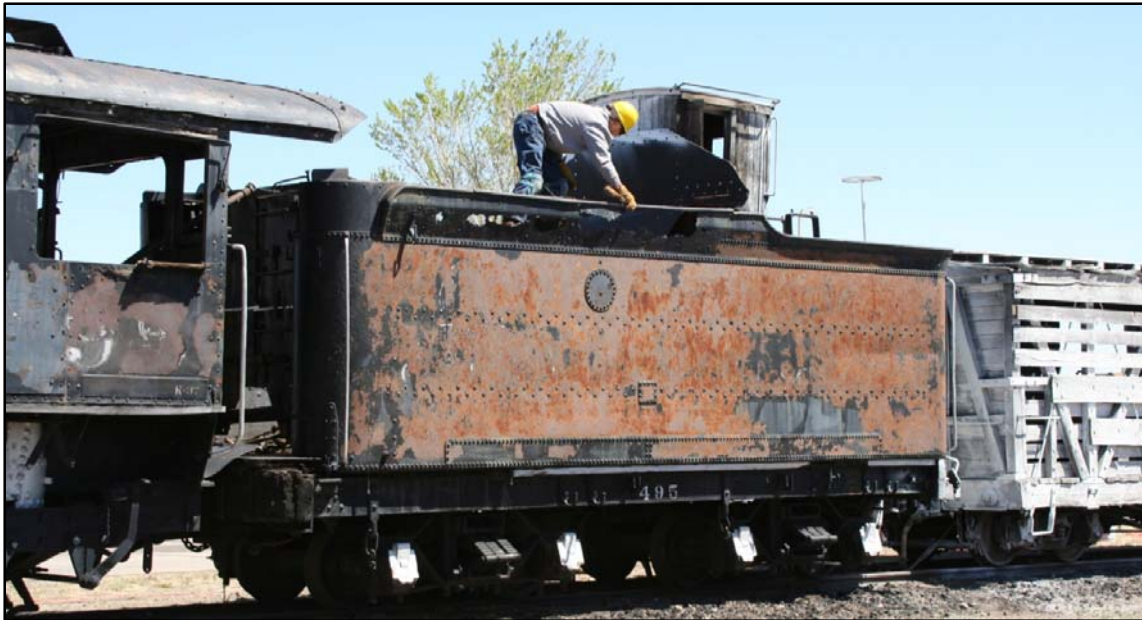
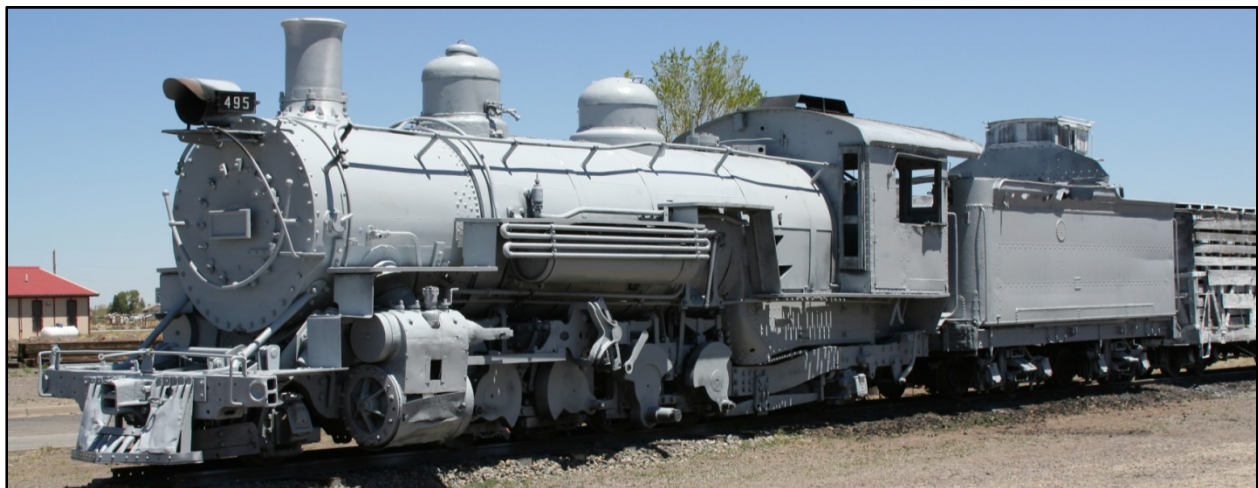
After priming on Tuesday, the locomotive was allowed to dry until Wednesday.

**D&RGW K-37 Locomotive #495** – This engine was primed and painted on Tuesday as the windy weather prevented earlier application. The black paint was applied Wednesday with the silver applied on Thursday morning. Final touch-ups of the black and silver completed the engine. It is now ready for lettering. It was previously lettered in the Flying Rio Grande scheme.

Locomotive #495 was scraped on Monday May 30, 2011. It had been pressure washed during Session A.

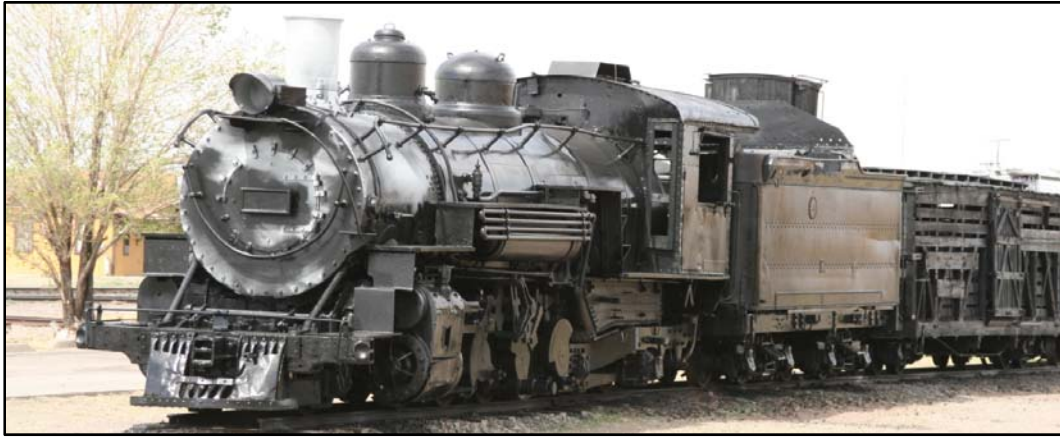
The locomotive was painted black on Wednesday. It was a windy day!

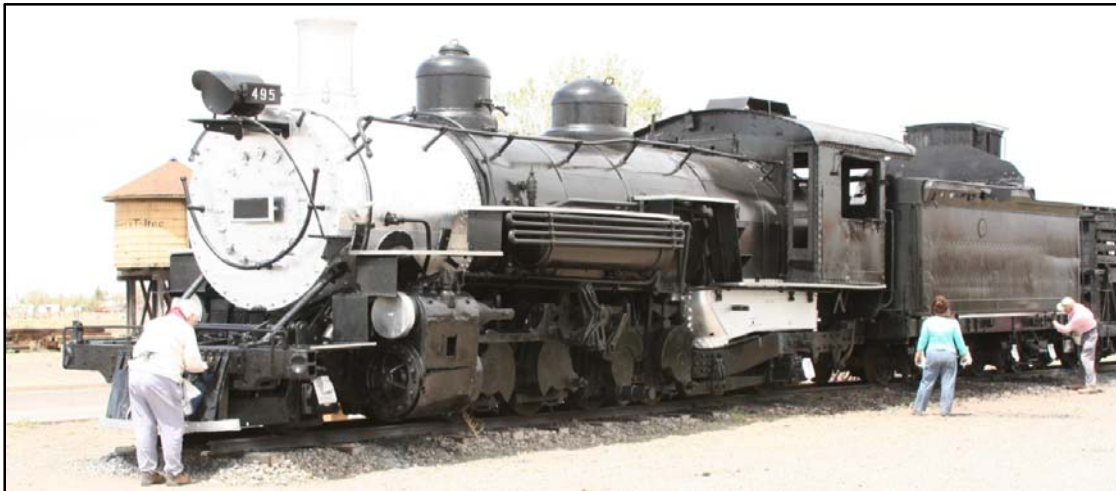
Final silver paint was applied and the locomotive finished on Thursday, June 2, 2011. It was another windy day!

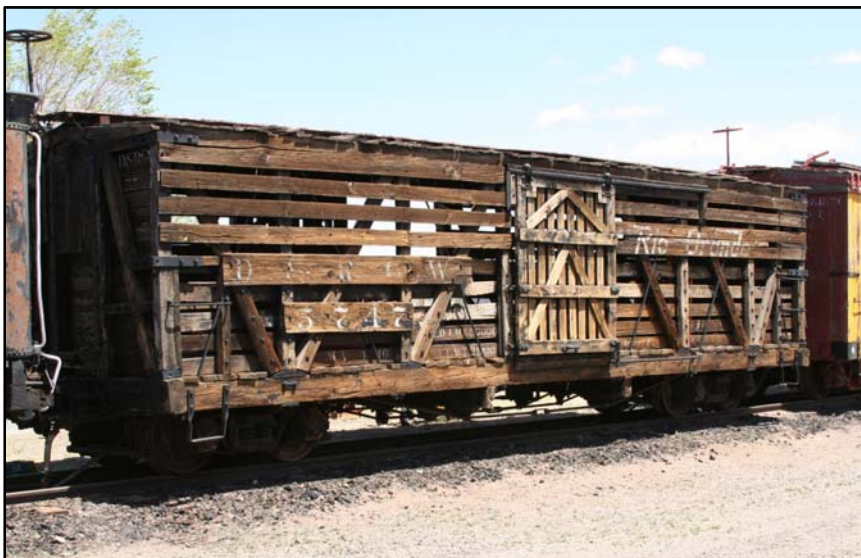
Stock car #5747 was prepared during the A Session. A light scraping was all that was necessary for the primer application.

D&RGW Stock Car #5747 – This car was primed on Tuesday and painted on Wednesday in Antonito. It is ready for lettering. It was lettered in the 1940's flying Rio Grande scheme.

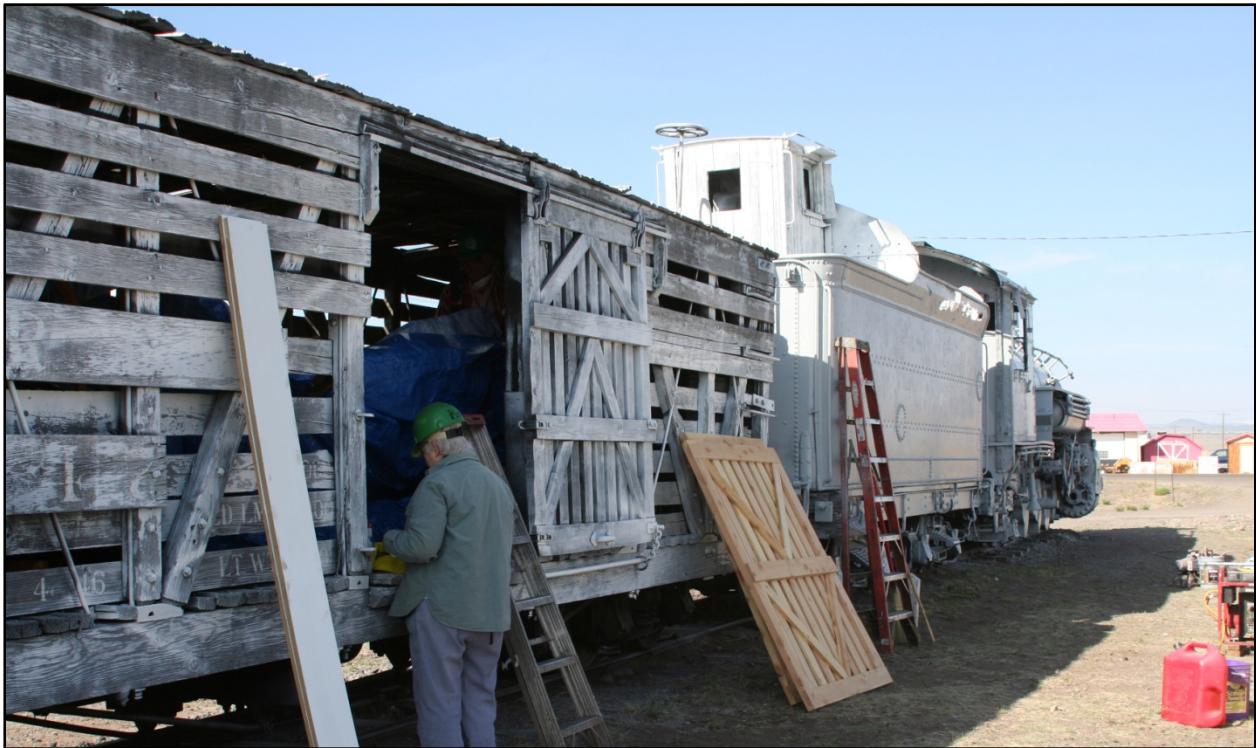
The stock car was primed on Tuesday, May 31, 2011.

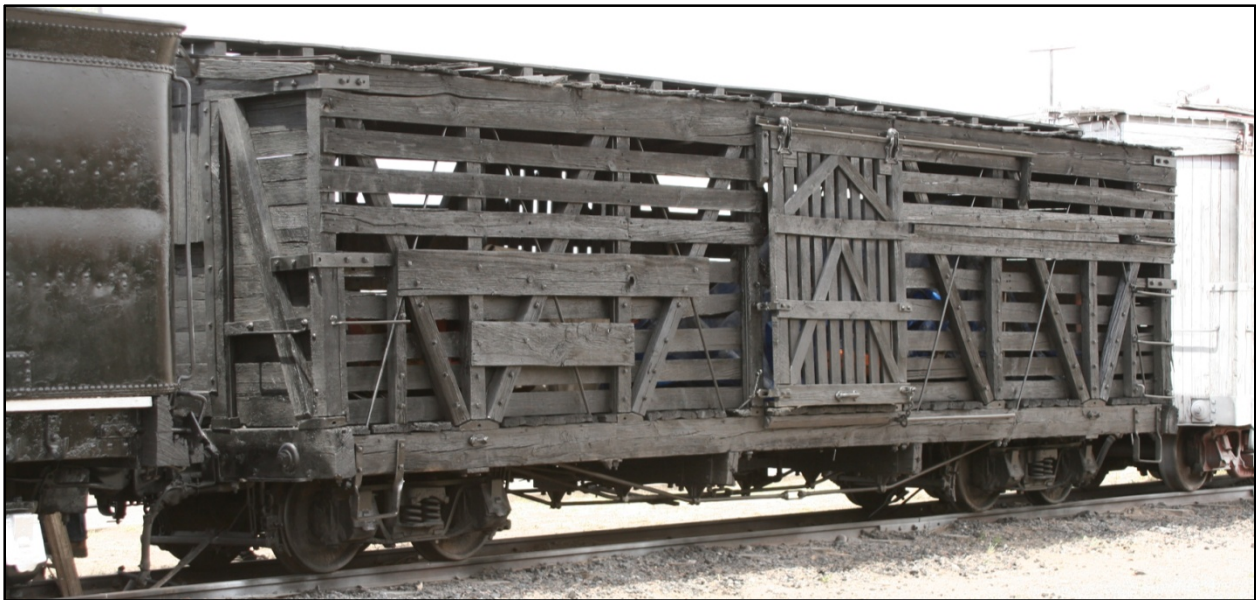
Finish coat was applied on Wednesday, June 1, 2011. This car is ready for lettering.

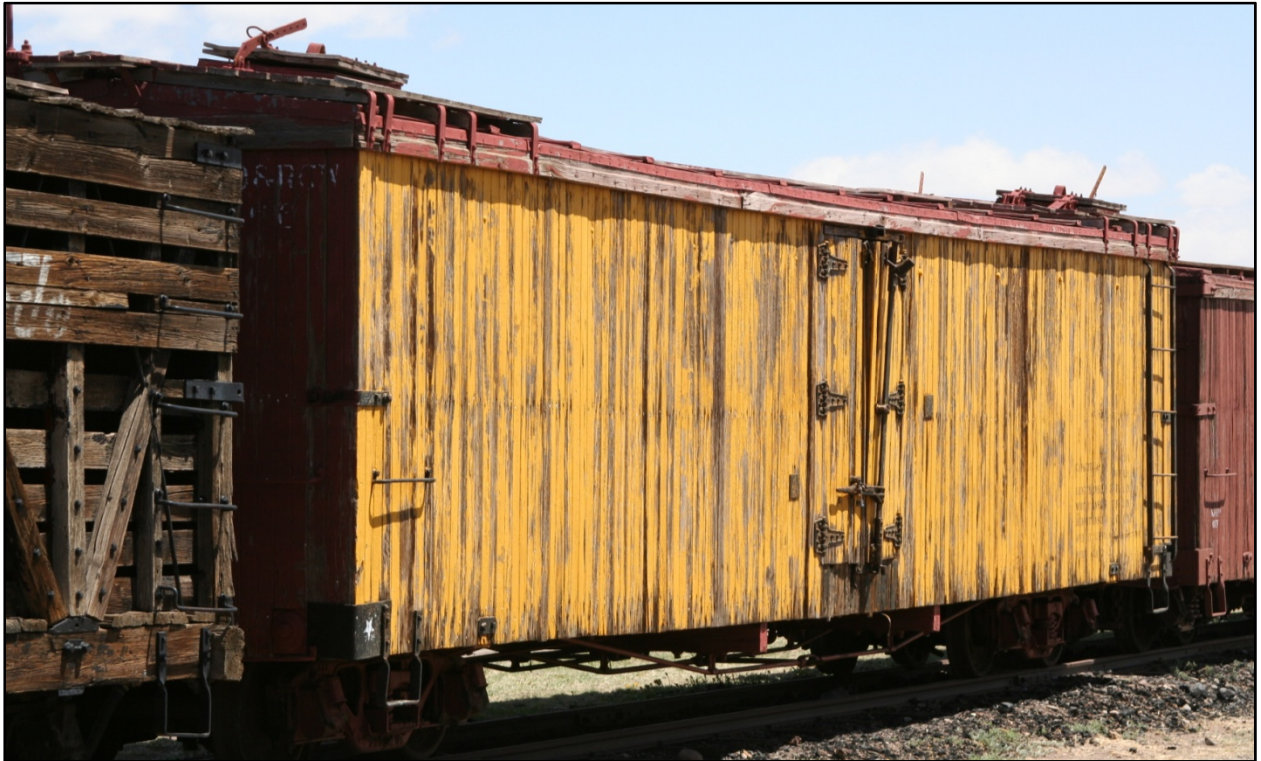
Final preparation of the Refrigerator car was completed during the A Session.

**D&RGW Long Refrigerator #166** – This car was primed on Tuesday and not painted until Friday due to high winds. It is now ready for lettering. It had the “Royal Gorge/Moffat Tunnel” herald.

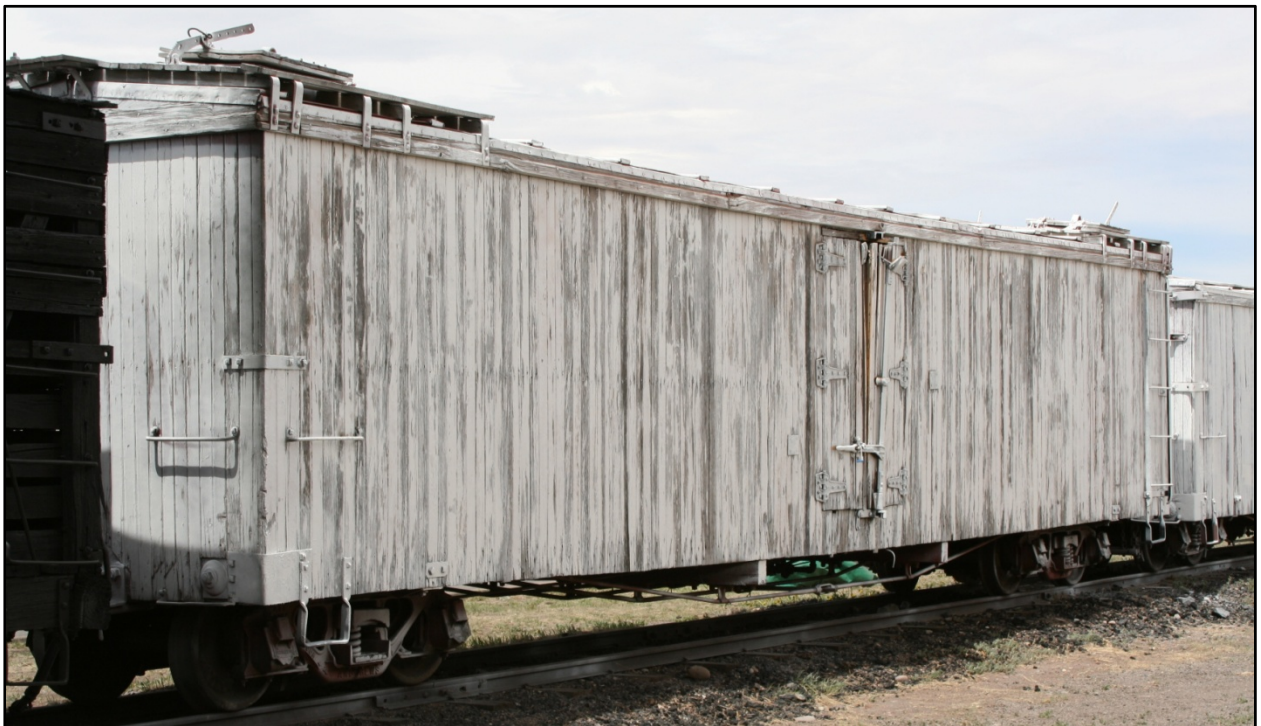
Reefer #166 was primed on Tuesday, May 31, 2011.

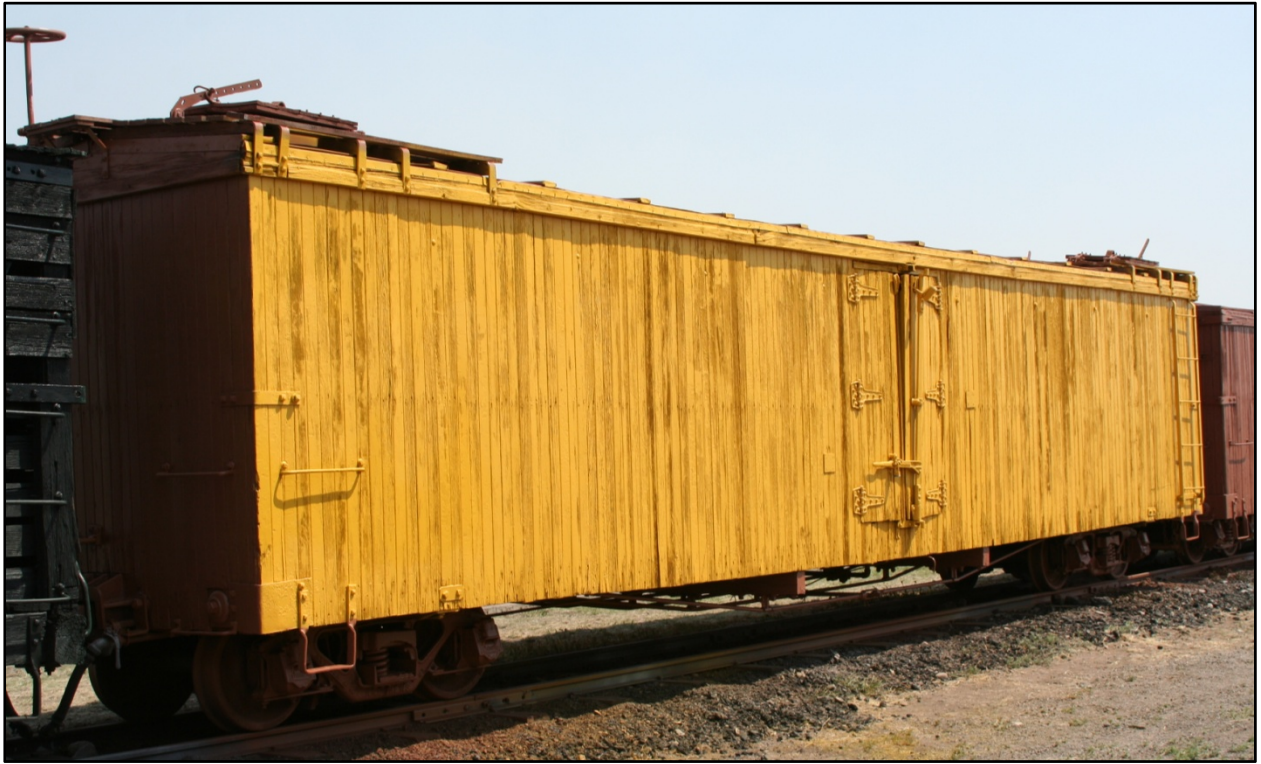
Reefer was painted on Friday June 3, 2011 and is ready for lettering.

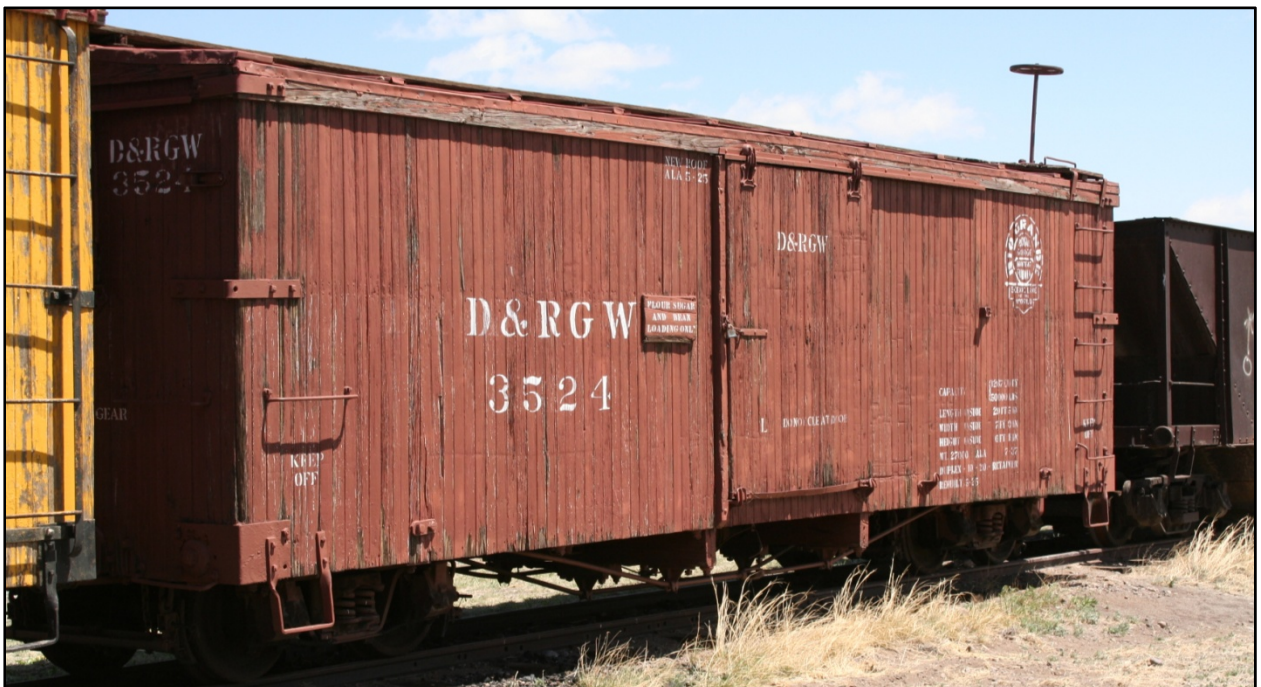
Boxcar #3524 had been prepared for painting during the 2001 a Session. A final scraping and cleanup was done on Monday, May 30, 2011.

**Box Car #3524** – This car was primed on Tuesday and finished on Friday as winds prevented the final coats from being applied until Friday morning (at 6:30 AM). It is now ready for lettering. It was painted in the “Royal Gorge/Moffat Tunnel” herald.

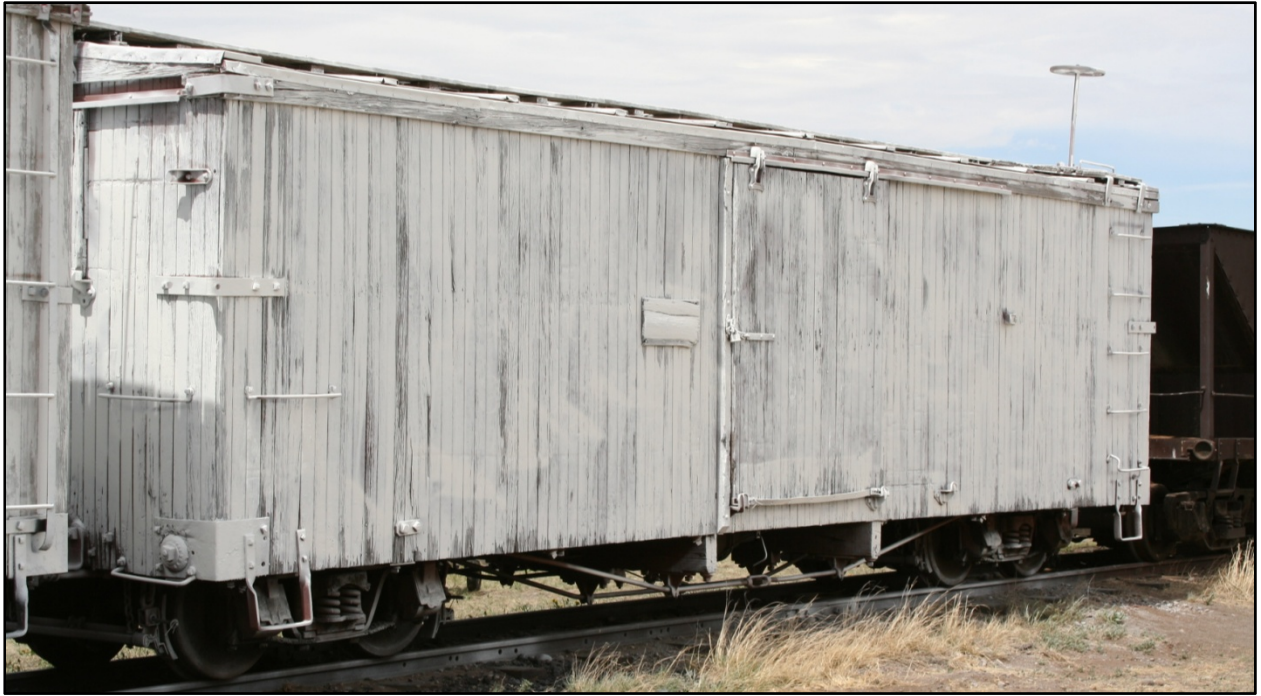
Boxcar was primed on Tuesday, May 31, 2011.

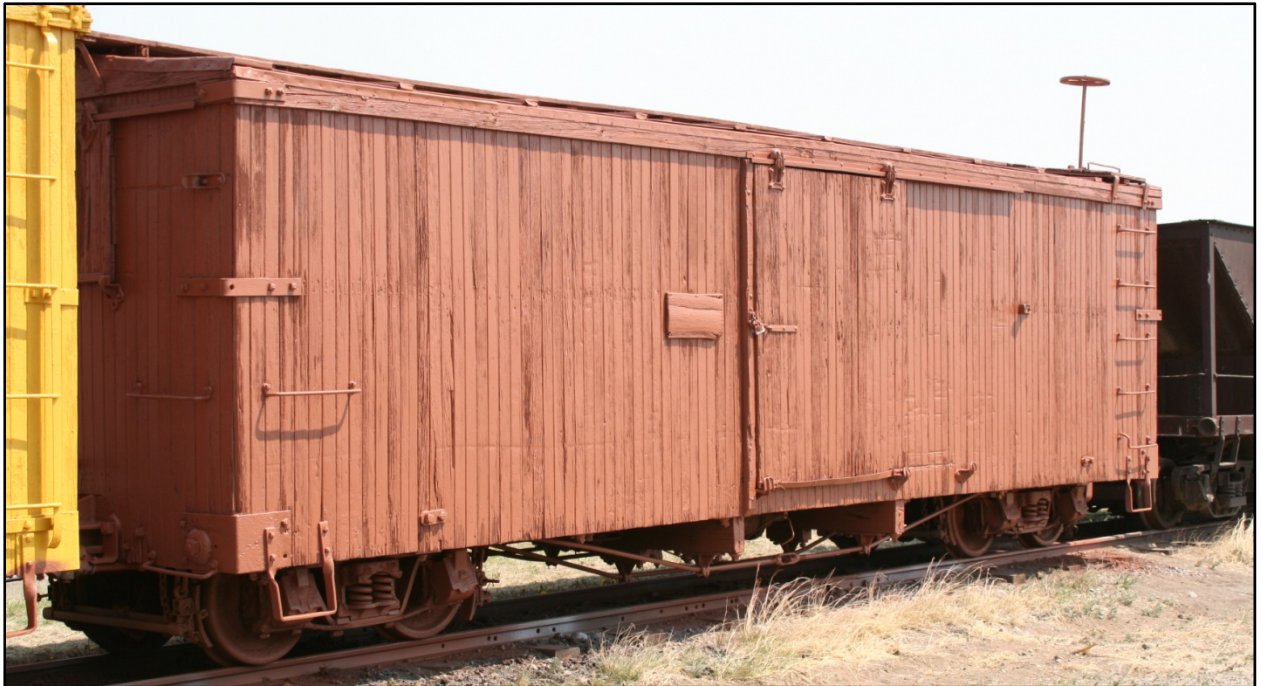
Final finish was applied on Friday June 3, 2011. It is ready for lettering
