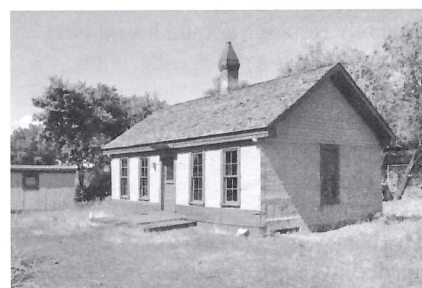
Chama log bunkhouse after cleaning and maintenance.

The team members made the front porch much safer by replacing rotted

ties and installing new planking. A threshold board was replaced and was painted with a brown oil-based paint that matches the color of the floor. What we have found in the past when we painted the threshold with latex paint is that it tends to blister very quickly. The team also glazed and/or replaced windowpanes. After the glaze had cured for three days, it was painted with a latex paint.

A new sash was made for the window on the south side. This sash was missing for a long time. In the past another sash was made but it was too small by several inches. Historically, each sash had four windowpanes. Some of the inside sashes and windowsills have never been painted. Two different shades of brown have been used in the past, one shade on the outside of the building and the other shade on the inside. The unpainted surfaces were painted with the historically correct shade of brown.

There are places on the outside walls where paint has peeled off the mortar. It has been six years since the outside of the building has been painted, but there were not many places where the painted had peeled. Where it has peeled there is concern about the exposed wood rotting, so these spots were painted with a special white primer that sticks well to wood and masonry surfaces. Once the primer was dry the team painted those spots with Rio Grande Gold finish paint.

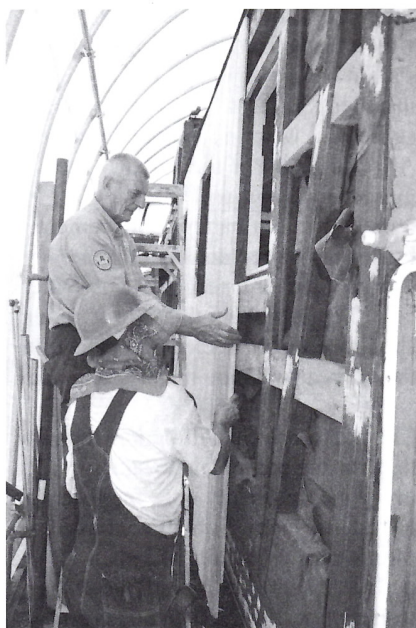
In Chama David Priddle (from the UK) and Mike Thode replacing siding on caboose 0503.

Inspection of the structural components of the body above the sills continued from last year. Of particular concern were the corner posts and their tenons. Three of the corner posts were repaired. All of the repair pieces done last year were glued and secured. The window sashes made during the winter (caboose main body only, not the cupola) were temporarily fitted to the caboose and their sills were fitted and attached. Nail holes along the sides of the caboose were epoxied and re-siding completed to just in front of the cupola from the B end of the car.

Team members removed the cupola's siding as well as the roof walk and stove pipe. The cupola was then inspected for structural integrity and rotten wood. The cupola had a noticeable sway fore and aft. The team placed plywood pieces in the walls between the slider windows. Metal brackets were fabricated and attached at each of the cupola's corner posts where they are tenonned into the main caboose body. New top sills for the cupola were installed to replace the ones suffering from severe rot. The original attaching rods were rethreaded at the roofline, with new nuts installed.

The cupola's sway was alleviated and it is now very secure and tight with the main body.

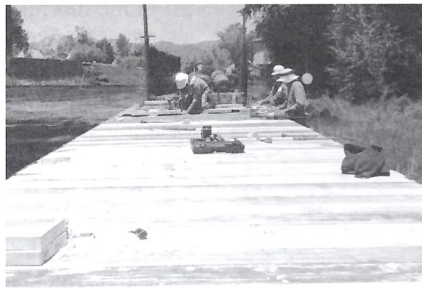
The team members have almost finished installing the new deck boards on flat car 6314.

We started with the car on its wheels, with a small portion of the deck

installed to hold the sills in place. The remaining deck boards had been cut to length and stored in a boxcar. The sills had been lined with roofing felt last year, but the winds had not been kind to it, so we began by repairing that installation, and extending it under the U-bolts holding the rails on. Russ Hanscom started relieving the boards for the bolt heads that stick up through the sills, the U-bolts, and the stake pockets. Russ did these tasks for the whole car by himself! John Schultz and Kit Trenholm installed the deck boards, using plot holes and ring shank nails, except on oak. Then we installed the stake pockets (four are missing). I cleaned the triple valve and packed the journals with pads stolen from one of the EBT hoppers. Mark Yates came up with a couple of 4-1/4 x 8 journal bearings to fill out our complement, and the car is ready to roll.

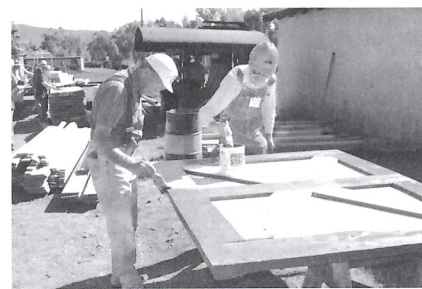
Geof Gordon and Larry Jennings painting boxcar door at the wood shop in Chama.

Working in Chama, the team completed a door from boxcar 3592. This

unique door was probably built around 1904. It is frameless, that is, there is no metal frame on the front. The only metal is a door runner on the bottom of the door. We completely rebuilt the door from the cook auxiliary boxcar 3483. This door was built completely from scratch except for the metal frame. For the record, it takes a 3-man crew a day and a half to do a complete boxcar door if they work at it. So, you can't turn one around in a day with 2 people – which is what we had this week. One of the problems is that boxcar doors do vary and there is no absolute template. Very often, as in this case, you must use the old one as a pattern rather than just build one and hang it, because they are not standard.
