Fairmont Speeder

MAINTENANCE-OF-WAY

STRUCTURES

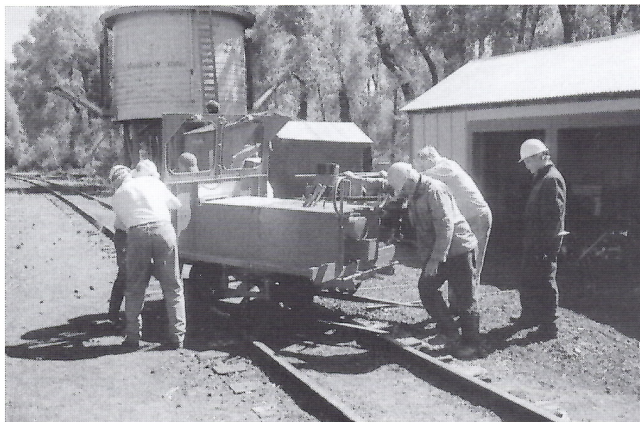
The Fairmont speeders being restored during session C; locomotive 487 switches cars in the north end of the Chama yard. (Photo by George Swain.) Below, the Fairmont speeder takes to the rails in Chama after rebuilding. The crew built a turntable to move the speeder on or off the rails. The new speeder shed is to the right (session D).

sessions. The team has restored D&RGW narrow gauge motor cars 04 and 013 to operating condition. The project involved the installation and testing of many systems and subsystems. Work completed during session C included completion of chassis assembly, gauging of wheel sets, and making final installation of brake rigging and brake levers on 04 and 013. With the exception of mounting the engine, work on 013 paralleled that on 04 (mounting the 013 engine was more complicated than expected). Before session D was over, both motor cars were tested. 04 ran smoothly, reversed easily, and demonstrated that it could pull a load when it towed 013 from one end of the yard to the other. Because of problems with timer and throttle controls, 013's engine didn't perform at its optimum level (these problems were addressed in session F in August). The team will letter the motocars in May 2004 and apply a series of plates providing maintenance and operating instructions.

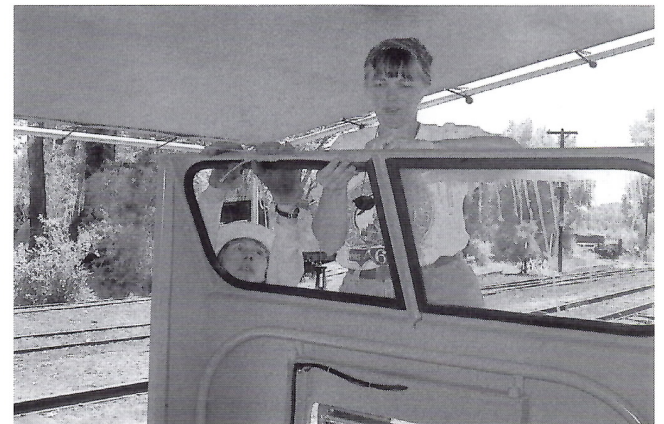
Noreen Breeding (l) and Laura Kammerer install weather strip in a Fairmont speeder's window (session D).

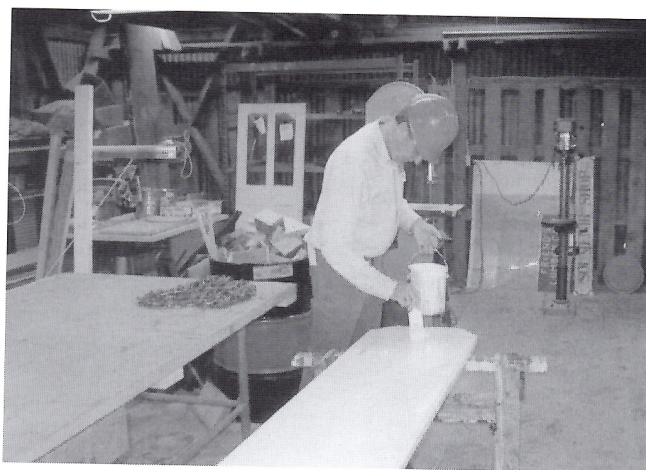
In Chama the rebuilt Apache Crossing telegraphphone booth ready for the move to its original site (session E).

The Apache Crossing telegraphphone booth, which was rebuilt and painted last year was replaced at its historical location on the right-of-way. The team brought the Rock Tunnel booth east of mile post 315 to Chama for repairs on the last day of the August work session. The Bighorn telegraphphone booth, which vandals turned over and rolled down the hill during the summer, will also be brought to Chama or Antonito when the railroad crew has an opportunity to obtain it this fall.
