Project 1003 – Cook Car #053 Restoration

Project 1004 – Restore RPO X54 as RPO 54

Project 1005 – Plan Car Inspector’s House Repairs – Cumbres – 330.640

Project 1089 – Repairs to Sheep Car 5633 - Chama

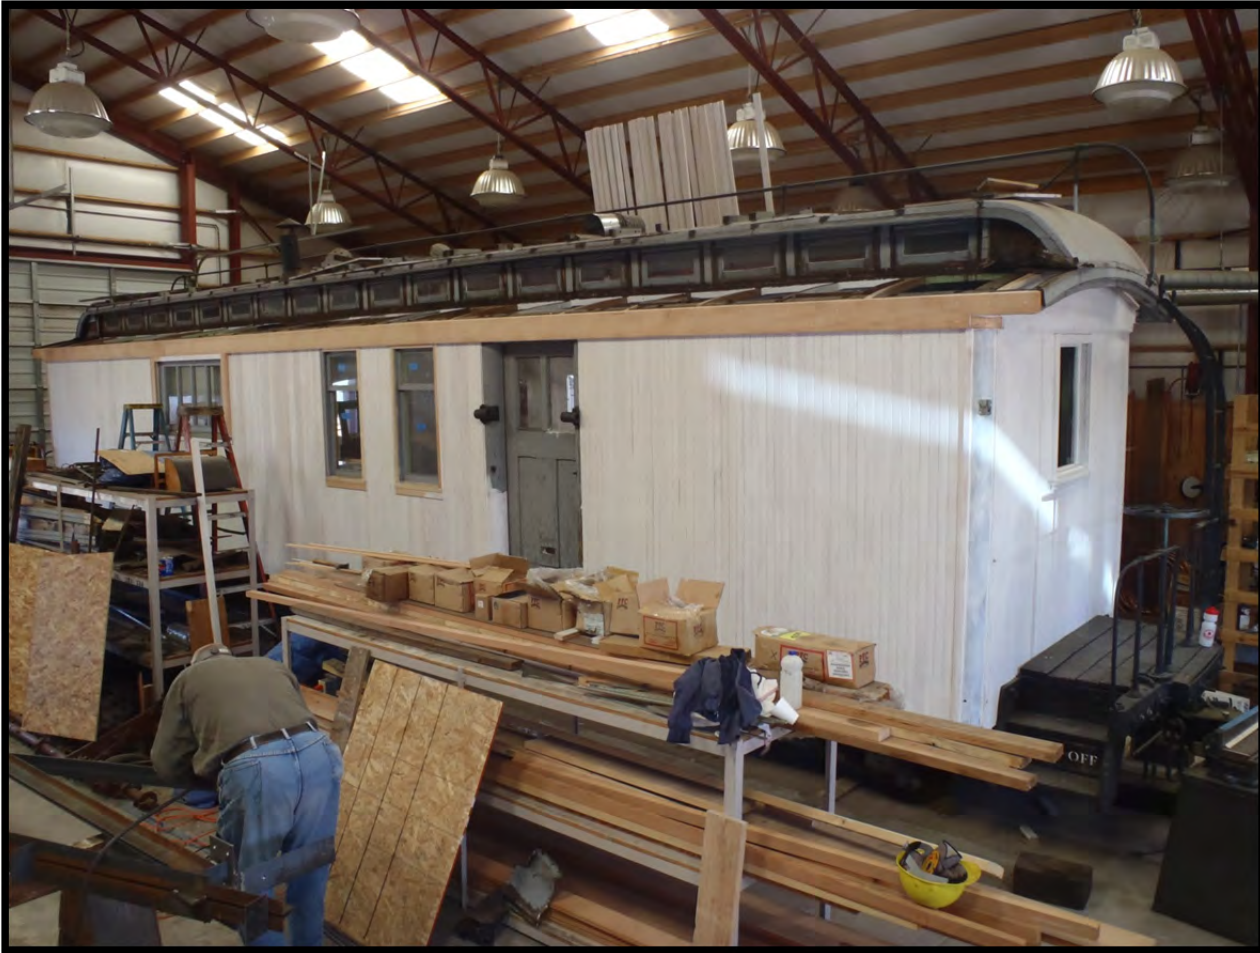
Car at the end of Session B. Both sides and both ends were completely sided during Sessions A & B.

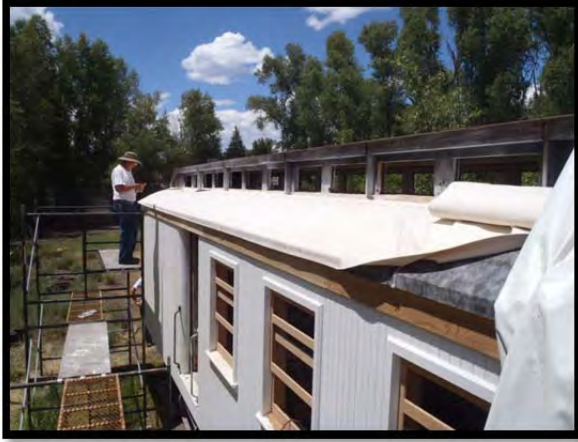
TL Don Bayer stops to re-load his stapler. Picture also shows window frames Don made last winter. They will be removed when its time to paint them.

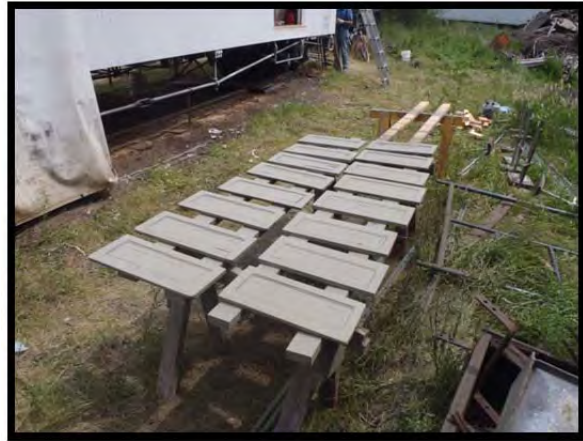
Clerestory windows have been primed.

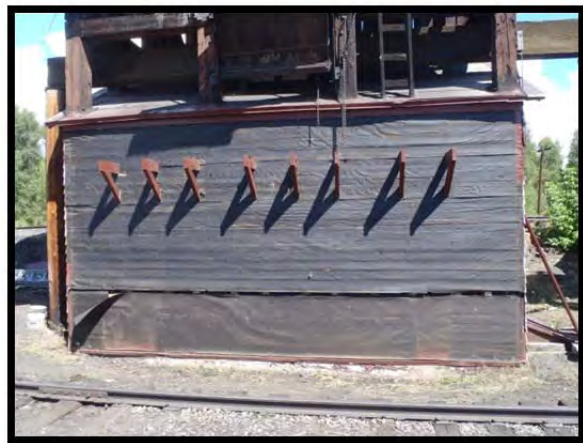
West siding has all been removed.

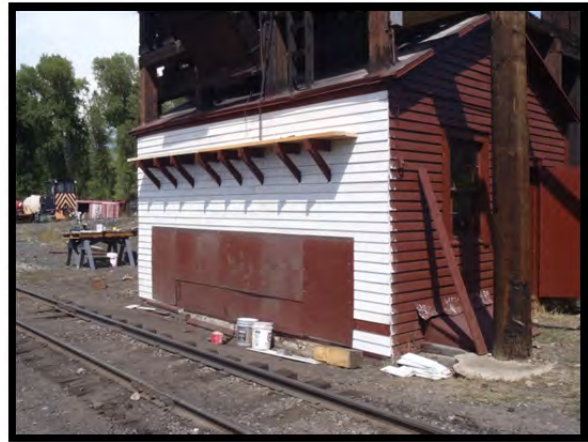
West side residing completed except for except for painting.

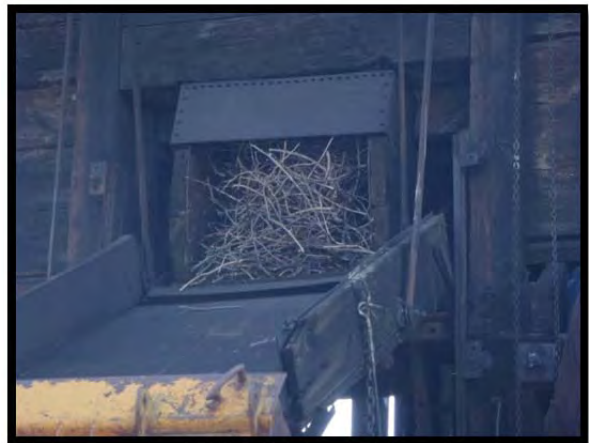
When TL John Sutkus raised the bunker gate a Raven's nest was exposed. It was interesting that the first thing that fell out of the bunker was a golf ball.

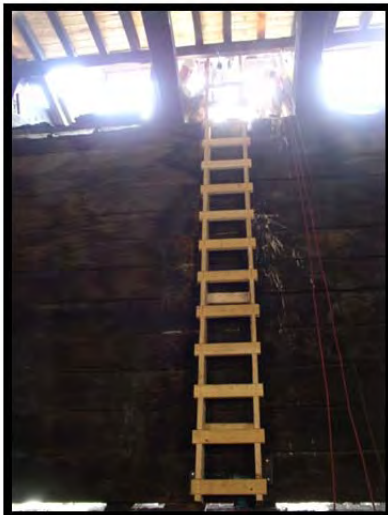
New ladder lowered into place.
(Photo by Gabrielle LaFargue)

Thursday, August 16, 2012 - Removed old bunker access ladder. Put new bunker access ladder in its place. Brought all tools down to ground level. Received permission from the railroad operator to lower the tipple chute and open the gate in order to remove the old bunker access ladder from the bunker. Lowered the old ladder out the gate and down the chute using a rope for controlled lowering. Closed the bunker gate and raised the tipple chute without incident.

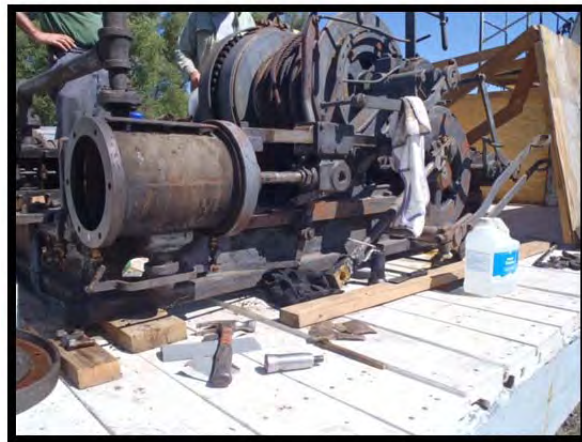
Side view of the two cylinder steam engine.

The valve covers and cylinder heads were removed from the two cylinder steam engine. The internals were found to be in excellent condition with no internal work needed except for one brass fitting that controls valve travel which was found cracked; it was repaired with silver solder. The lubrication and drain systems were cleaned and new piping and gaskets were installed. Replacement of the existing schedule 40 steam piping with schedule 80 piping was started.

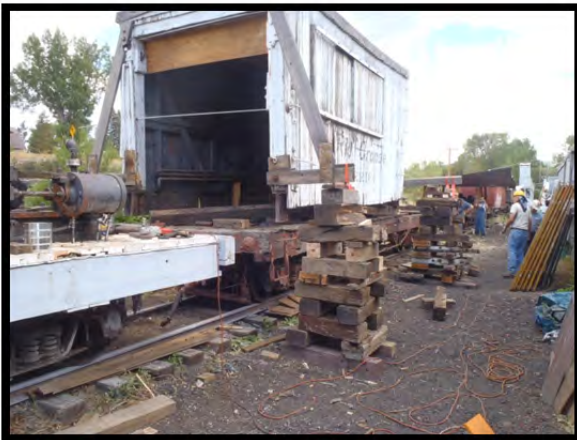
OP's cabin has been raised by cribbing to clear the flat car so it can be moved out.

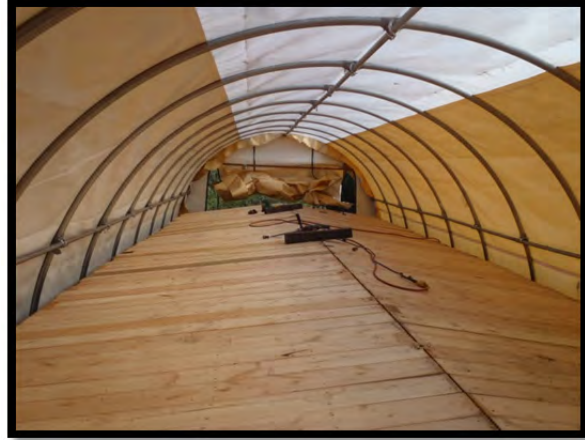
Finished wood roof.

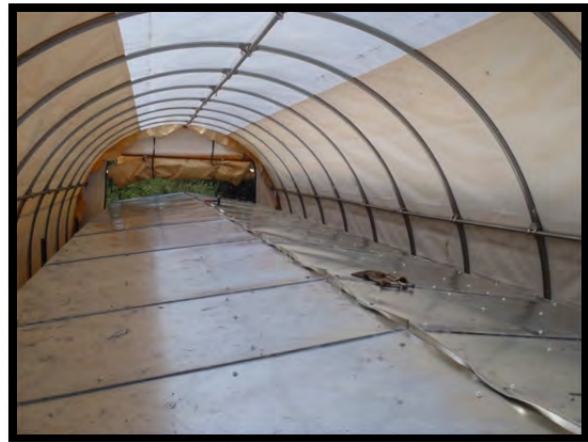
Finished metal roof – the roof walk was also added.

Attached metal roof on top of wood roof.
Installed roof walk (except for end braces).
Installed new upper letter boards.

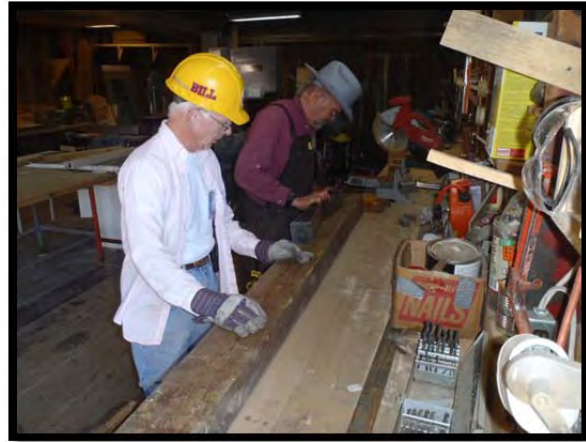
Bill Lock and Jim Hickman mark a piece of wood that they cut new roof walk supports.

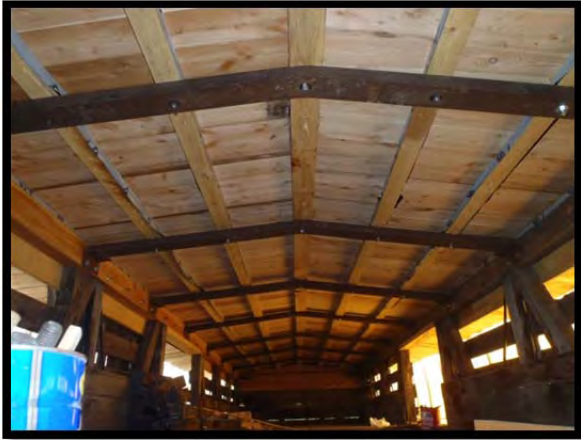
View under the new wood roof.

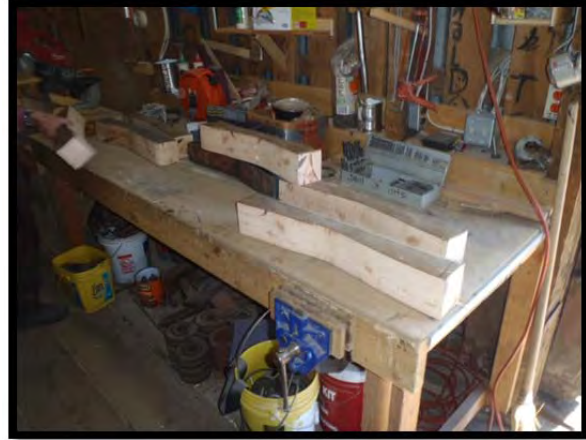
New roof walk supports cut out of one piece of lumber.

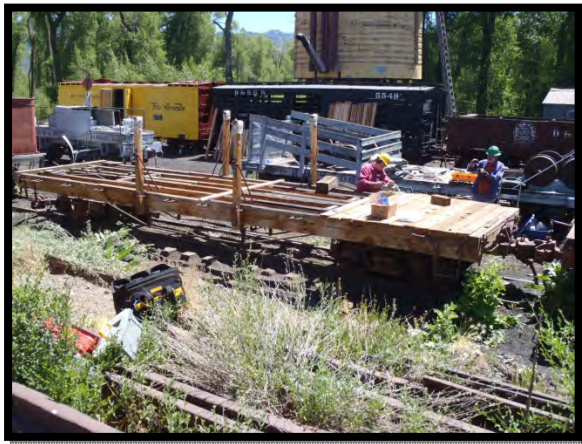
Car at the beginning of Session D

Work Accomplished: The B end coupler was installed. The original coupler was defective so a replacement was obtained from the swamp. Installing the decking was completed, all side posts were installed, and the first two layers of side siding was installed on both sides. The siding was installed with only one of the two bolts at each post in order to expedite installation. The second bolt at each position will be installed during the next session

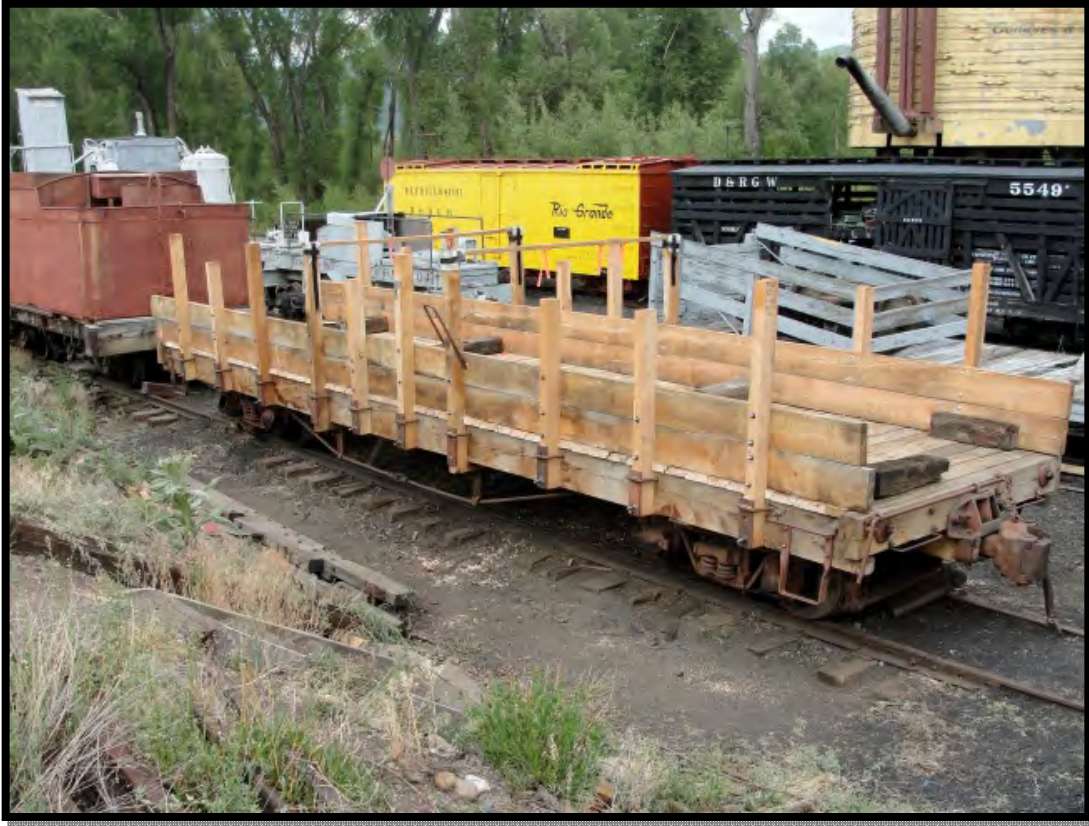
9558 at the end of Session D.

Project Status: What additional work is required? The remaining three side boards on each side, all side “cripple” posts, the end siding, and all corner angle plates must be installed. All “above deck level” safety appliances and brake controls, and the B end air hose and angle cock also need to be installed. The B end Simplex coupler installed during this session is missing its knuckle but Marvin said that he has one for it.

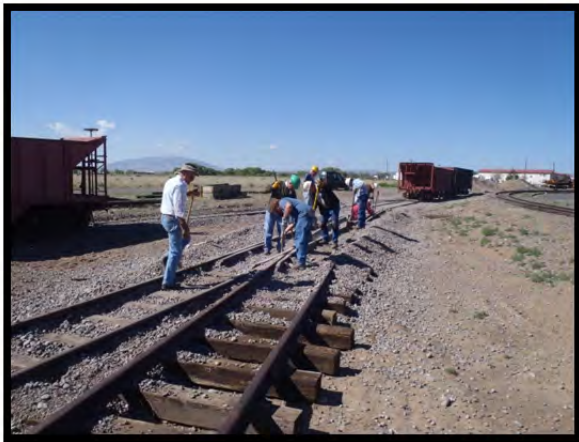
Team removing ballast so switch stand and throw rods could be installed.

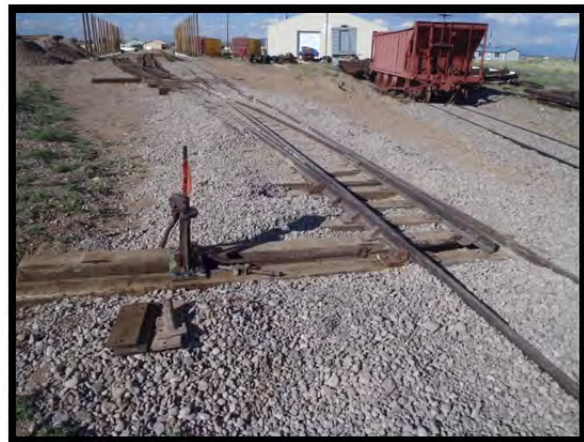
Switch Stand and throw rods installed.

Cut and weld throw rods, install switch stands and adjust switches to specifications for switches on track 1 and 2.
Align tracks 1, 2 and 3 from track 1 switch to end of track.
Extended track 2 to end of building.
Dumped 2 cars of ballast on track 1 and raise track 1 to approximate position as far as possible.
Cars were stored on track to be worked.

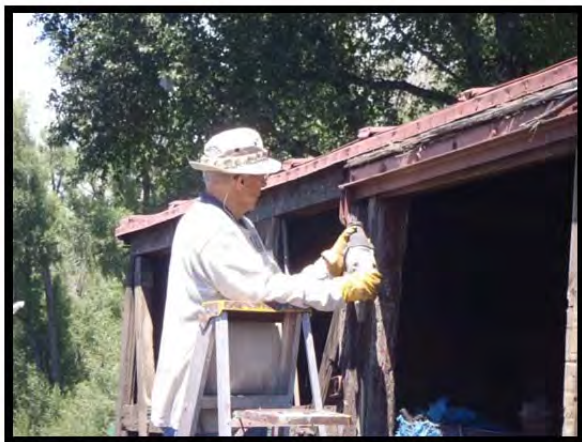
George Davies uses a “sawsall” to cut a bolt.

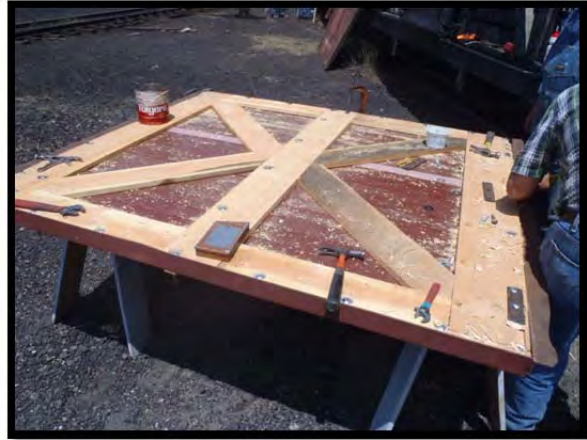
One of the doors almost finished.

The work on the doors was almost a separate project itself. Both old doors were completely disassembled and rebuilt. One of the door tracks (on the side we completed) was removed. This allowed replacement of the entire fascia and various backing blocks and spacers. Reinstallation of the door brought with it many reminders to those of us who have forgotten some of the details of this work from years past.

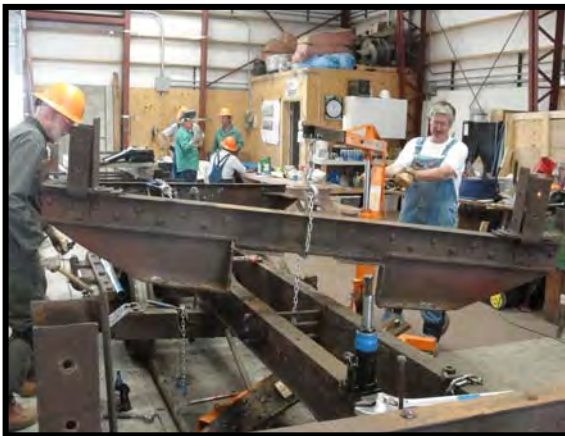
Warren Ringer and Randy Parks removing a frame cross member. (Photo by Bill Pratt)

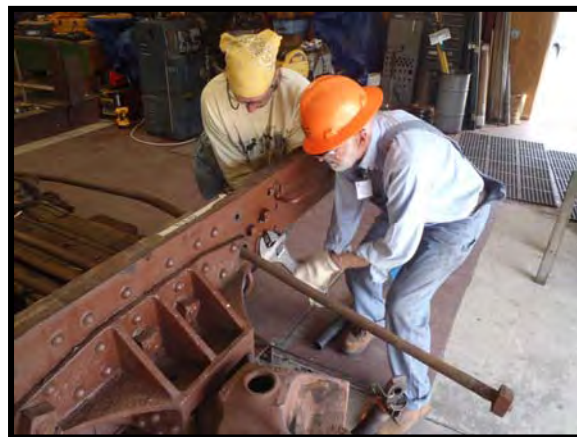
Lee Parks and Warren Ringer removing a nut from a bolt. Tear down is one bolt at a time!

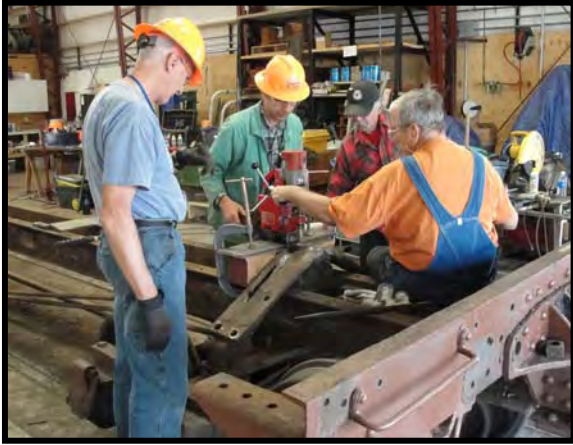
Removing a bolster saddle. (Photo by Bill Pratt)

Removal of the frame cross members and bolster saddle was required so that this wood could be replaced. It is planned to use Huck Bolts instead of “hot rivets” when reinstalling the three center cross frame members and the B end bolster saddle.

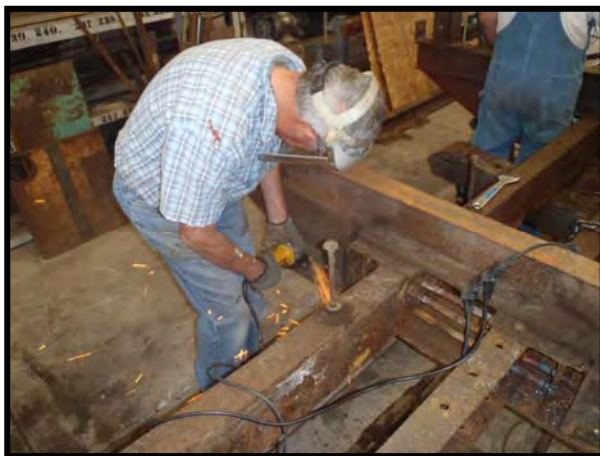
TL Bill Pratt grinding off a rivet head.

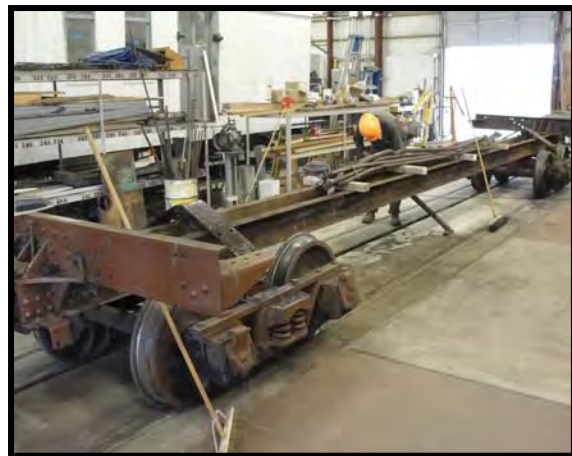
At completion of the session with the truss rods stowed on top. (Photo by Bill Pratt)

The truss rods must be inspected, weld repaired as necessary, have the threads chased, and the truss rod holes in the end sill castings must be rebored.
